**WHY  
BUILDINGS  
FALL DOWN**

How Structures Fail

MATHYS LEVY  
and  
MARIO SALVADORI

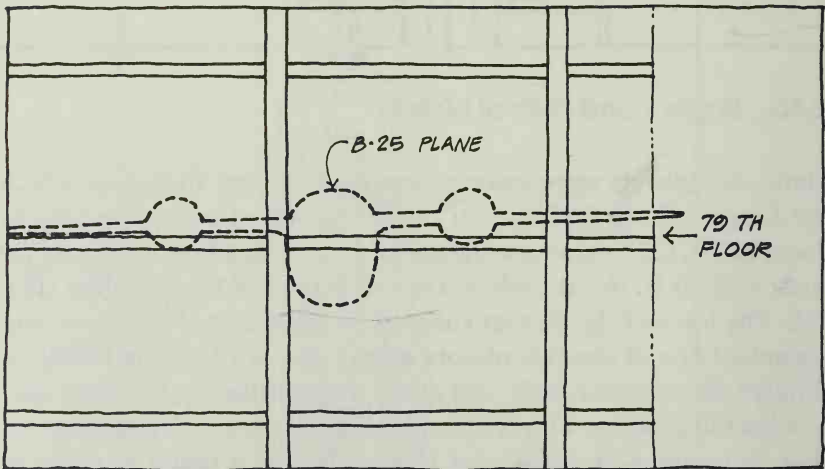
The center of impact aligned almost exactly with a column on the face of the tower. The right motor passed on one side of the column and the left motor on the opposite side (Fig. 2.4). The column itself was barely damaged, although a steel beam supporting

2.4 B-25 Straddling Column

the masonry wall struck by the right motor was torn out, and a second beam supporting the floor slab was bent back 18 in. (450 mm). The plane apparently struck the seventy-ninth floor dead-on, which explains the lack of damage to the column. Had the plane been just a bit higher or lower, it might have struck and bent the column, and then . . .

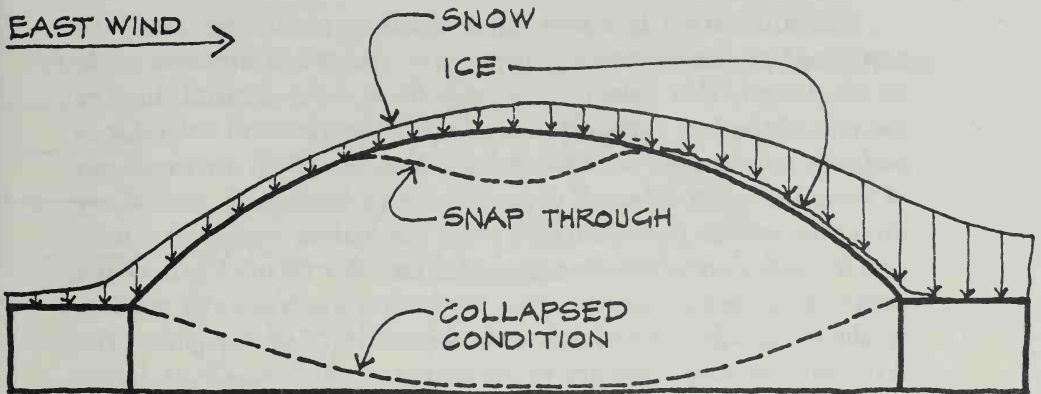
### 3.12 Stages of Collapse of C. W. Post Dome

Three days later Nicholas W. Koziakin, a structural engineer with the renowned New York City office of Mueser, Rutledge, Johnston and DeSimone, inspected the site and, after numerous additional visits, presented on May 10 his thorough but qualitative report. He concluded mainly that the dome had been underdesigned by a simplified theory *inapplicable* to the reticulated dome structure, based on the assumption of *uniform* dead and live loads, and that the nonuniform snow blown on the dome by the wind, and the ice found under the snow the day of his first visit, may well have stressed the structure above allowable limits (Fig. 3.12). He advised that a more realistic model of the reticulated dome should be analyzed by a rigorous theory to check the design. Weidlinger Associates was entrusted with this analysis, and its report of May 1979 proved Mr. Koziakin's conclusions to have been entirely correct. As in some other structures, for the reticulated dome of the C. W. Post center "less was more." A snow load of only *one-fourth* the load required by the code but concentrated over a sector *one-third* of its surface was bound to collapse the dome! Indeed, that had been the story on the night of January 21, 1978, when a load of snow blown by an east wind had lodged onto the *leeward* side of the dome.

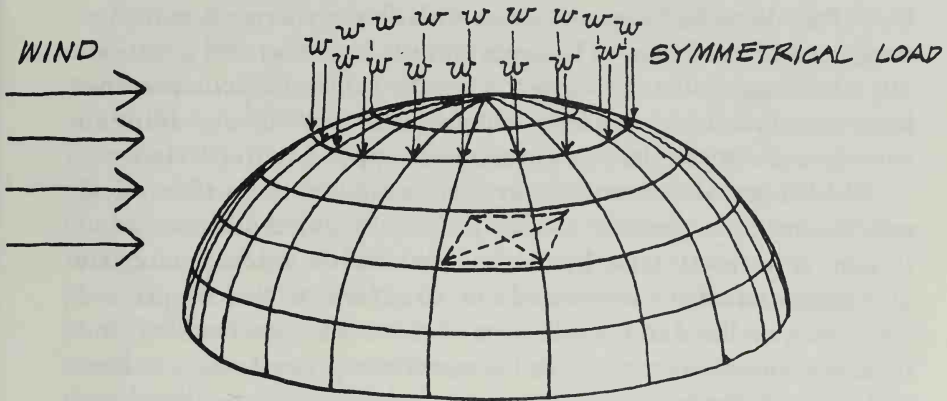
### 3.14 Skewing of Rib Meshes Caused by Wind

But perhaps the most dangerous consequence of using membrane theory in the design of shallow reticulated domes is that under symmetrical gravity loads its meshes *shrink* (slightly) on all four sides, *remaining square*, while under wind loads they become skewed (Fig. 3.14) and require diagonals to be stable. Finally, since most of the bars of the mesh are compressed, reticulated domes must be checked against the dangerous phenomenon of *instability in buckling as a whole*, which causes the dome to invert or *snap through*. (You may easily check instability in buckling by pushing down on a thin metal or plastic ruler that will bend out at right angles to its thin surface and lose all capacity to resist compression higher than a small push [p. 289, Fig. D4].) Rather unwisely the

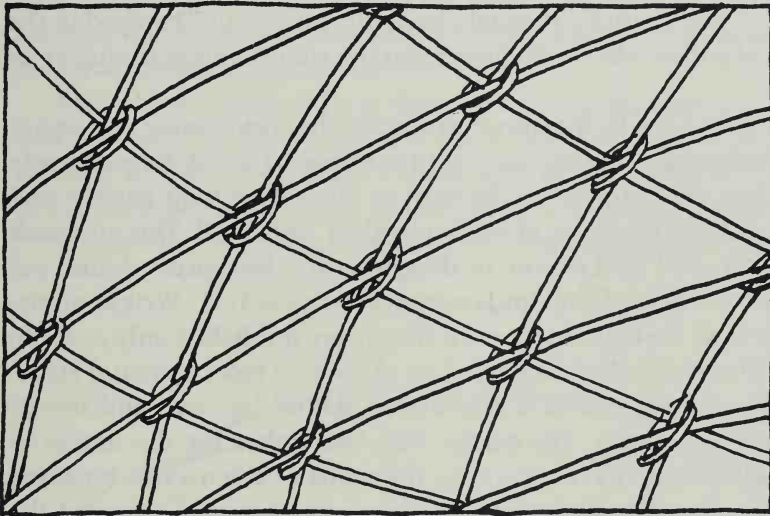
3.16a Bar Arrangement in Bucharest Dome

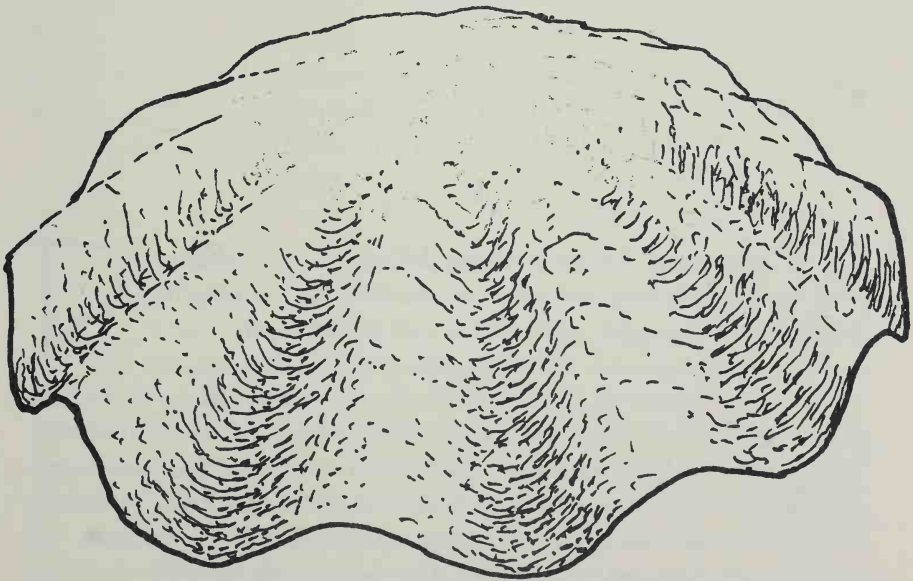
3.17 Local Radial Buckling of a Dome

Soare also remarked later that the bridle node connections had been entirely unable to prevent the relative sliding of the pipes meeting at the nodes. Rigid connections at the nodes of a reticulated dome are essential to maintain unchanged the geometry of the dome and to prevent bending deformations at the joints; no

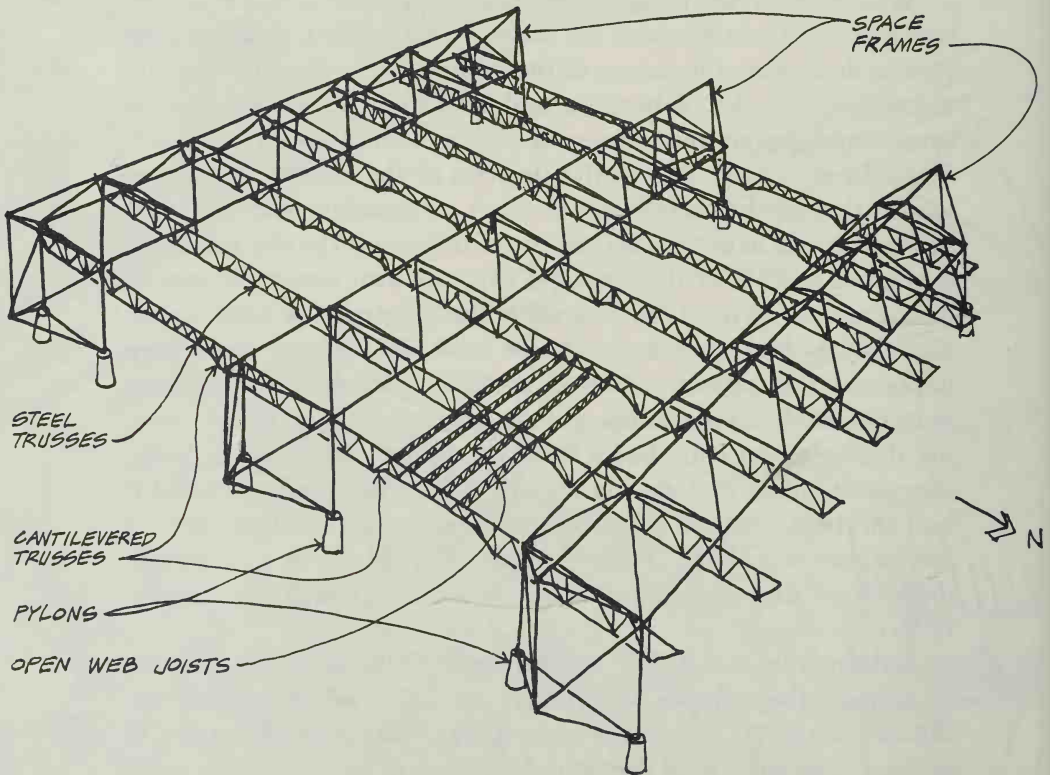
4.4 Diagrammatic Layout of Structure of the Kemper Arena

The basic structural elements supporting the loads of the roof itself and those acting on it, as well as the weight of the upper part of the walls of the arena, were three external space frames spaced at 153 ft. (46 m) in the north-south direction in the shape of rectangular portals, 360 ft. (108m) long in the east-west direction, and 81 ft. (24 m) high (Fig. 4.4). The horizontal element, or beam, of the portals consisted of a *space frame* of steel tubes with an equilateral

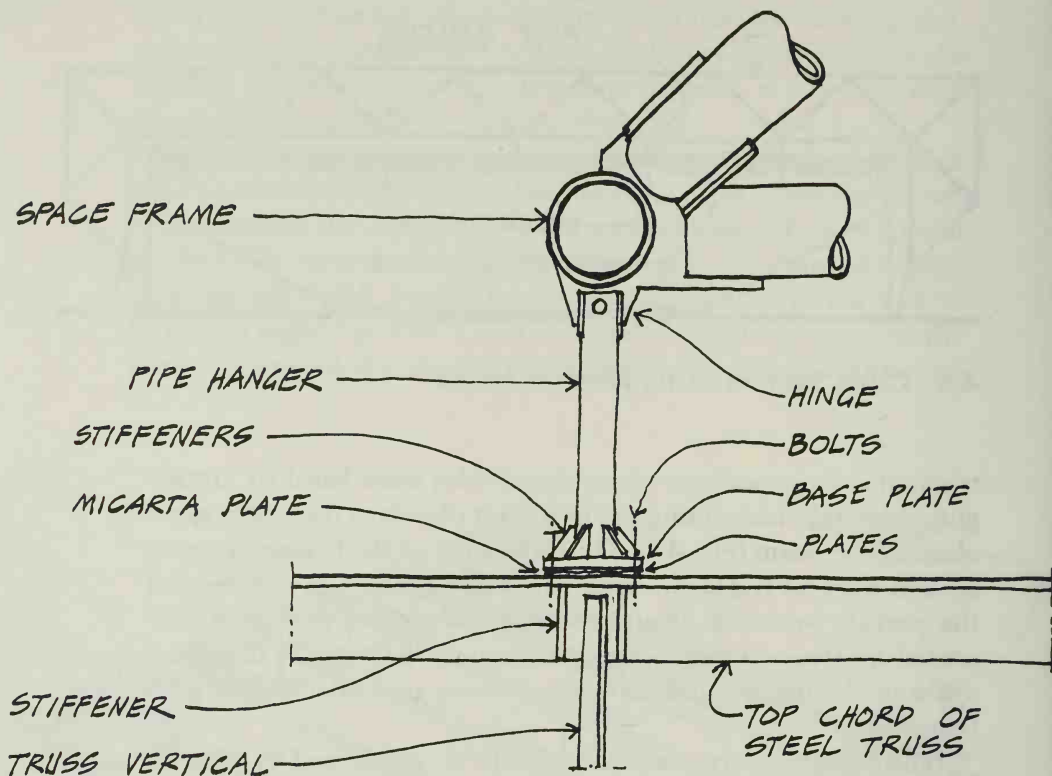
#### 4.6 Components of the Hanger Assembly

The hanger assembly, because of its two essential functions, does not consist of a simple rod as the word "hanger" may have implied to the reader (Fig. 4.6). Since the weight of the roof itself is 26 psf (1.3 kN/m<sup>2</sup>), or about 1,500 tons, and since the roof was designed to carry 25 psf (1.25 kN/m<sup>2</sup>) of additional load caused by rain, the load of the mechanical systems, and other hanging loads (or about

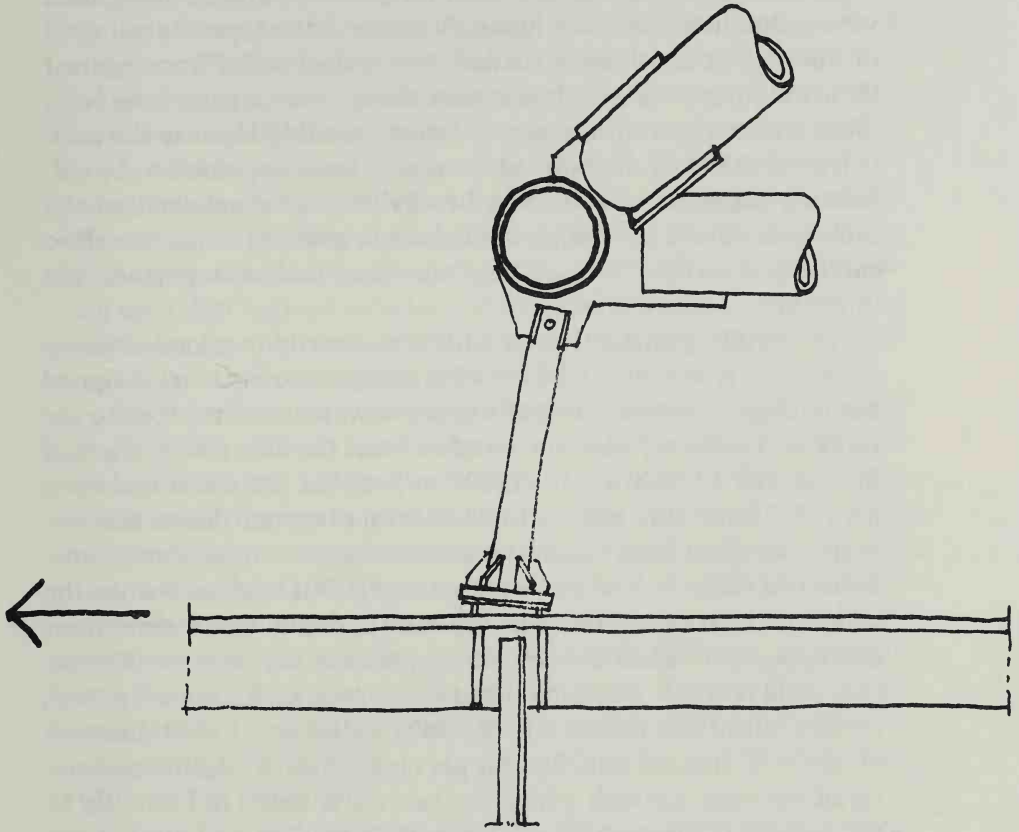
#### 4.7 Hanger Assembly: bent by Lateral Force

another 1,500 tons), then each of the forty-two hangers was to support in *tension* 140,000 lb. (622 kN). Moreover, they had to resist the horizontal, variable wind forces (exerted on the roof and on the upper part of the walls hanging from it), which tended to move the roof horizontally as a gigantic pendulum. For this purpose six of the hangers were hinged both at their top and about halfway down their length, while the remaining thirty-six were hinged only at the top and connected (almost) rigidly to the top chord of the large trusses. While the two-hinge hangers allowed the roof to move as a pendulum, the single-hinge hangers limited the horizontal roof motions to the *bending* deflections of these hangers (Fig. 4.7).

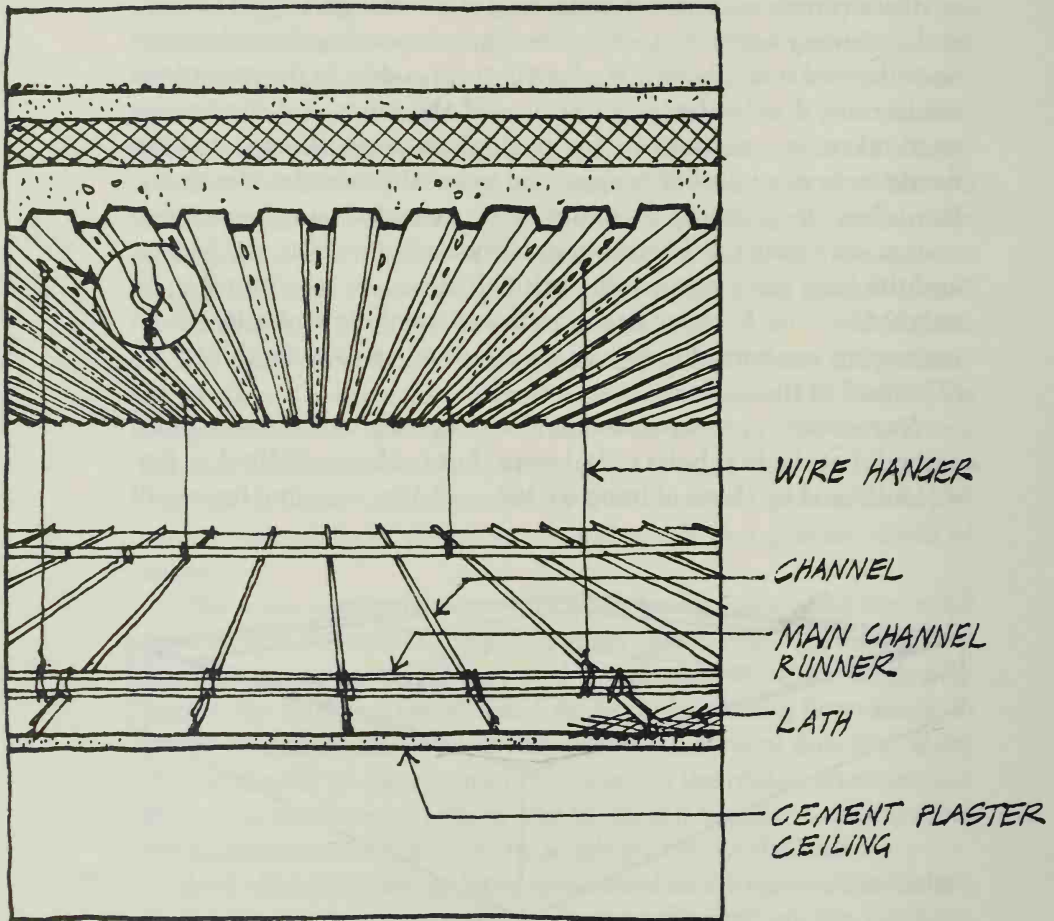
4.9 Components of the PATH Railroad Station Ceiling

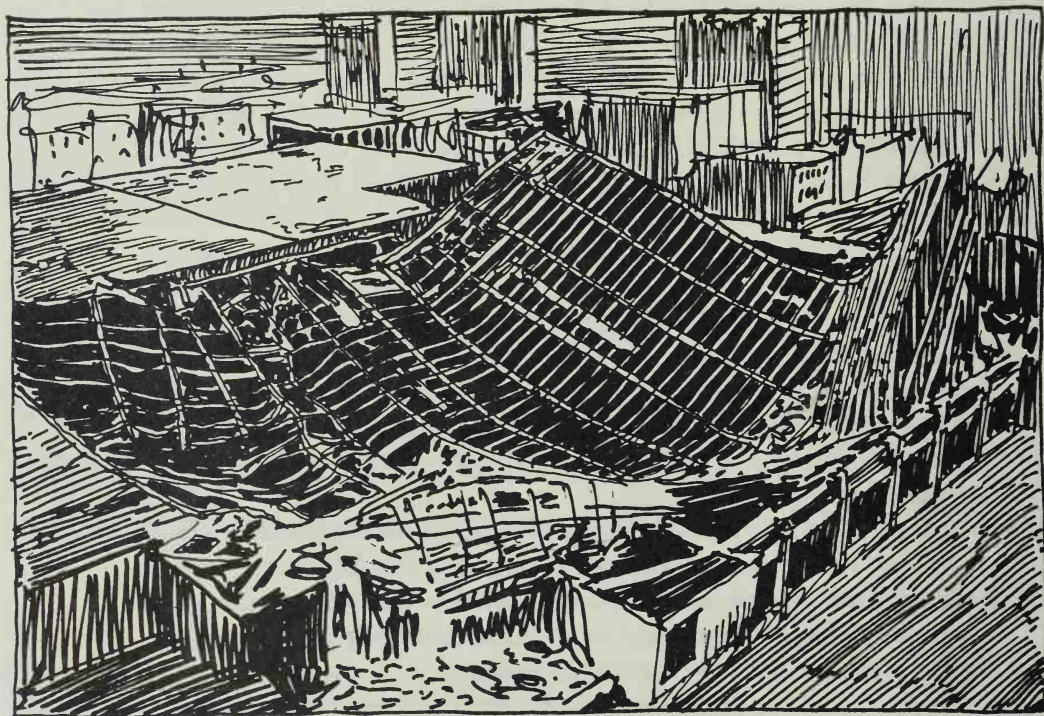
4.10 Hartford Center Roof: after the Collapse

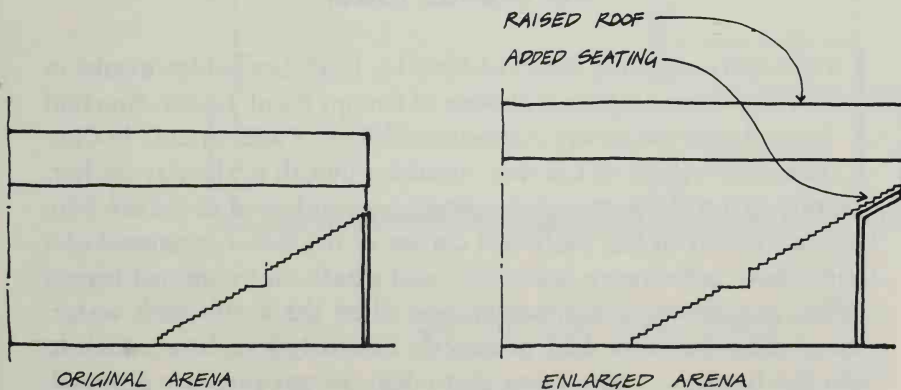
4.15 Section through Original and Enlarged Arena

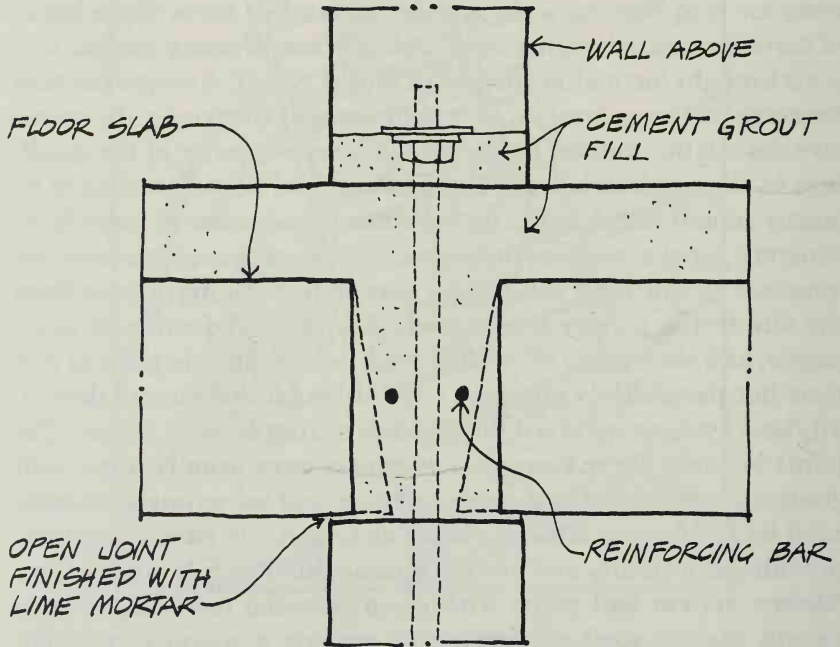
### 5.3 Joint between Interior Wall and Floor Slabs

push a wall panel off the floor. Since the explosion in Miss Hodge's apartment did not damage her eardrums, it was deemed to have caused a pressure against the wall panels of less than 10 psi (0.07 N/mm<sup>2</sup>). Yet tests showed that this pressure, equivalent to that felt when one swims under only 10 ft. (3 m) of water, was high enough to cause the failure of a reinforced concrete wall either by bending it or by overcoming the friction resulting from the gravity loads and kicking it out. Tests conducted by experts from the tribunal established by the government to determine the cause of the collapse showed that the wall panel would slide out against the floor panel at a pressure of 2.8 psi (0.02 N/mm<sup>2</sup>), less than one-third that of the explosion. A witness in a nearby factory reported seeing the wall of Miss Hodge's living room "come out as if pushed sideways and then fall," which is consistent with the fact that the strength of the wall panel in bending was greater than the resistance of the joint in friction. Had the explosion occurred on a lower floor, the loads compressing the wall panels and the resulting friction might have been large enough to have prevented a failure of the wall by sliding.

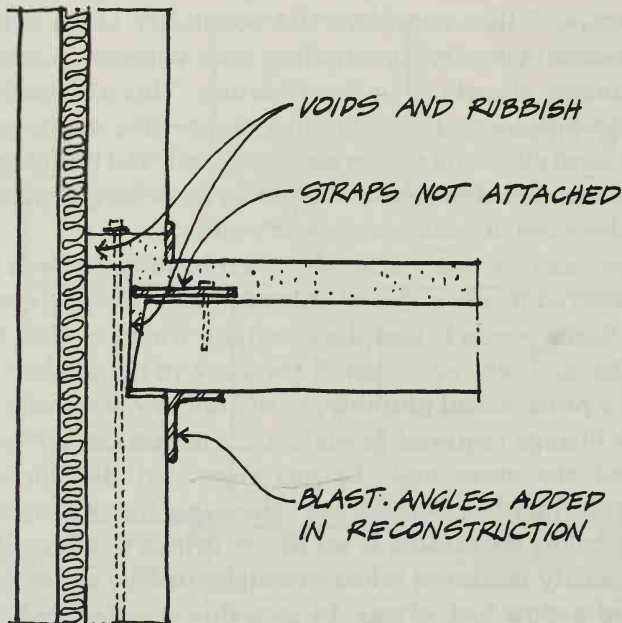
5.4 Joint between Floor Slab and Outside Wall—Reinforced after the Blast

The need to strengthen Ronan Point was obvious, but discussions about what to do and who should pay for the remedial work moved the matter into the sociopolitical arena. Within a year of the disaster the debris was cleared away, and the wing rebuilt with a *blast angle*, a reinforced joint detail preventing the separation of the wall from the floor. The tower was reoccupied; but in 1984 cracks began appearing in other walls, and the entire tower was evacuated. Eventually, in May 1986, the building, which the press had dubbed the "Infernal Tower," was swathed in a coat of reinforced polystyrene to contain the dust of demolition, and the tower was demolished, floor by floor, in a procedure that reversed that used in construction. Forty-one weeks later only the foundations remained, a monument to a failed dream of industrialized construction gone only eighteen years after its erection. Since it would have cost six times more to strengthen the tower in accordance

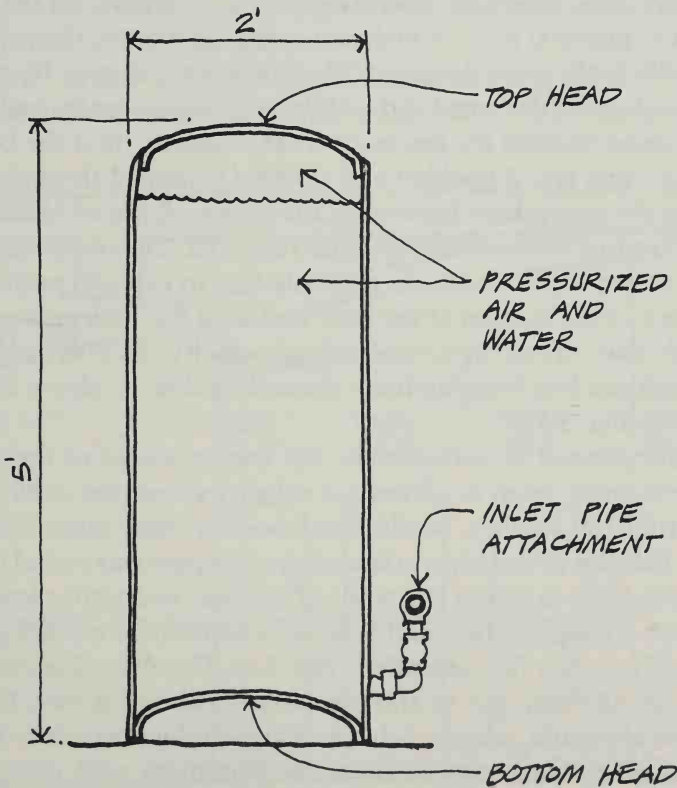
## 5.5 Hydropneumatic Tank

Very early on the morning of the blast an employee of the photo lab went to the basement and closed the safety switch on Tank No. 2, instantly starting the pump, but when he returned to the lab on the sixth floor, he noticed that the pressure gauge there showed almost no pressure in the system. He went right back to the basement to check the problem and found Tank No. 2 lying on its side on the floor and water flooding the area from a broken pipe that had been connected to the tank. He also smelled gas. He left immediately to call for help, but before he could reach the lobby, a powerful explosion engulfed him in dust and flying debris.

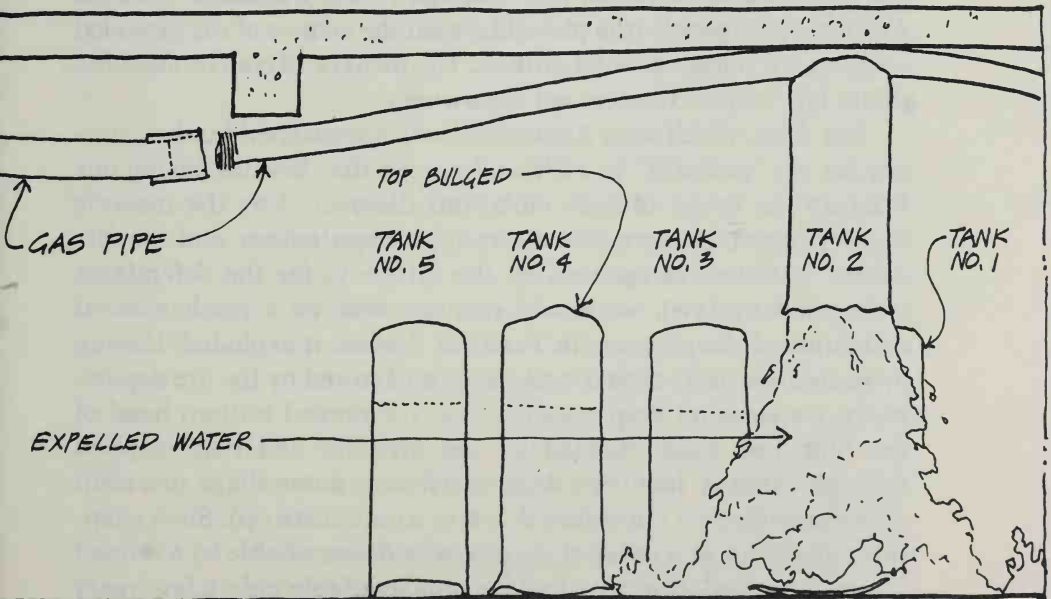
5.6 Ruptured Tank Striking the Gas Pipe

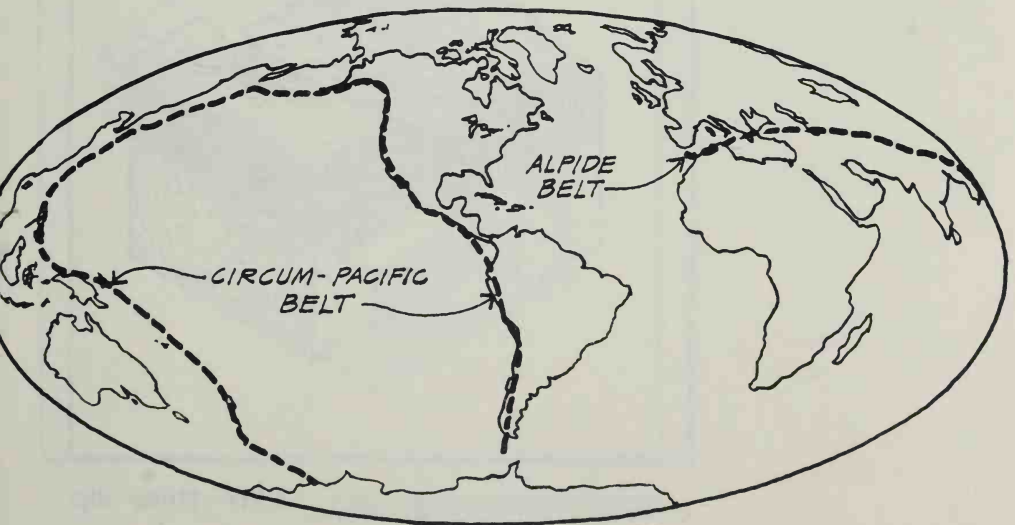
6.1 World Seismic Bands

The earth's crust is like a broken eggshell floating on the viscous inner magma of melted rock. Plate tectonics, the recently developed theory of movements of the earth's crust, offers the most plausible explanation for the existence of bands all over the globe along which most earthquakes occur. These bands contain *fault lines* or cracks that are, in fact, the edges of the tectonic plates and, as correctly observed by Strabo, occur primarily along continental coasts (Fig. 6.1). These giant plates move relative to one another

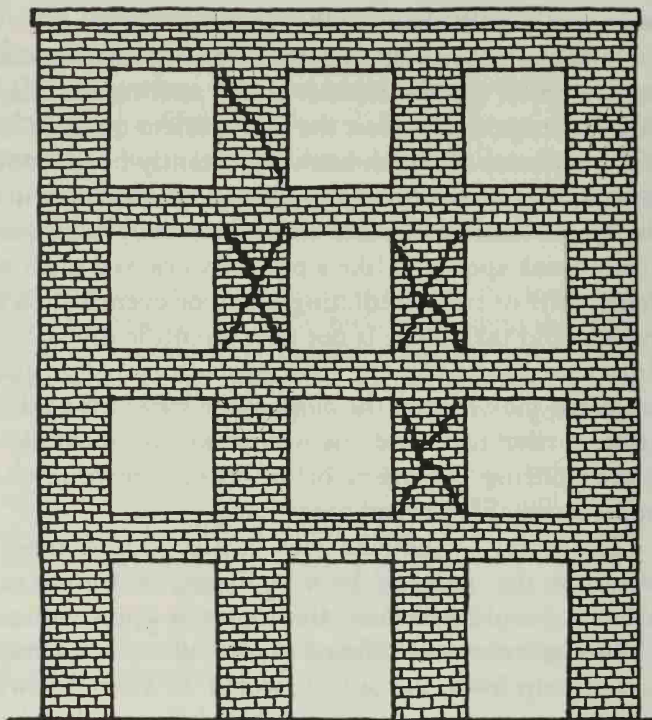
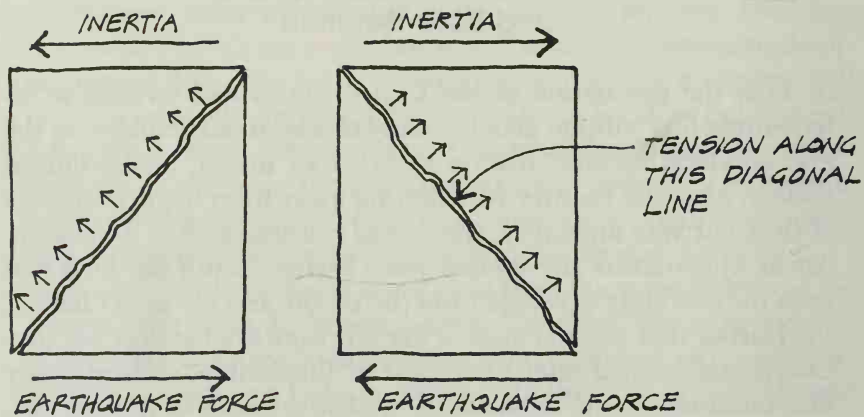
#### 6.4 Diagonal Cracking of Masonry Wall

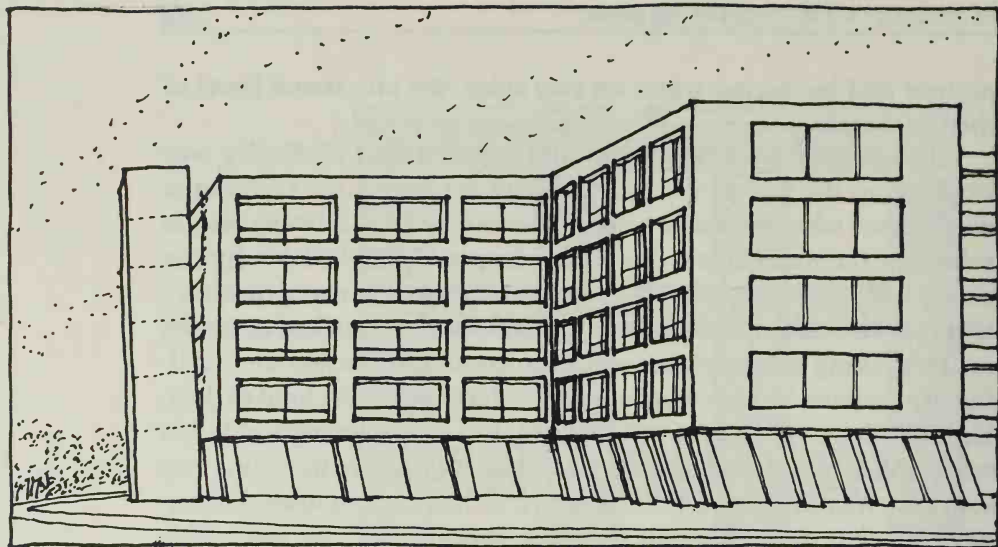
### 6.5 Olive View Hospital: After the Earthquake

Masonry walls supported on cast-iron columns and beams survived almost intact since the iron frame acted as a horizontal shock absorber, damping out the intensity of the seismic force before it reached the wall. This concept, known today as *base isolation*, represents an important approach in enhancing the earthquake resis-

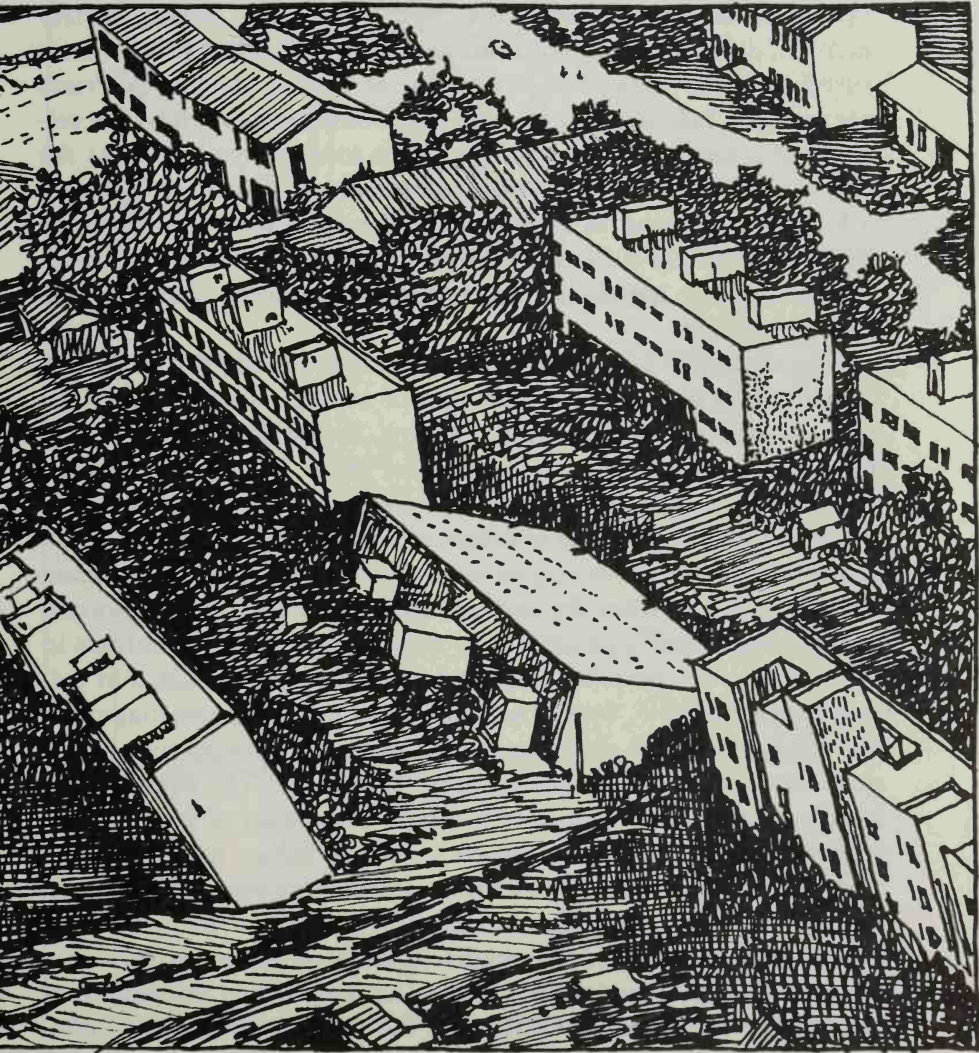
6.6 Niigata Apartment Buildings: After the Earthquake

urated with water that suddenly become liquid when subjected to shaking from the quake. To demonstrate this action, place a weight on a pot full of sand to which water has been added almost to the top. Shaking the pot will cause the sand-water mixture to liquefy and the weight to sink and/or tilt. This is precisely what happened in Niigata, Japan, in 1964, when an apartment building tilted through an angle of  $80^\circ$  from the vertical without breaking up, so that after the movements stopped, the occupants were able to walk to safety down the face of the building (Fig. 6.6).

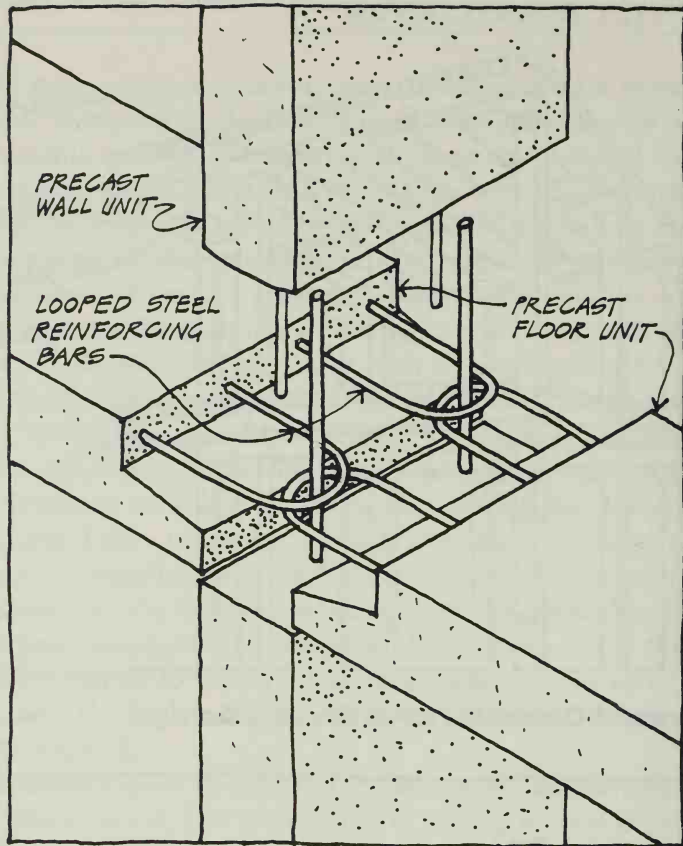
### 6.9 Detail of Joint between Precast Concrete Wall and Floor Panels

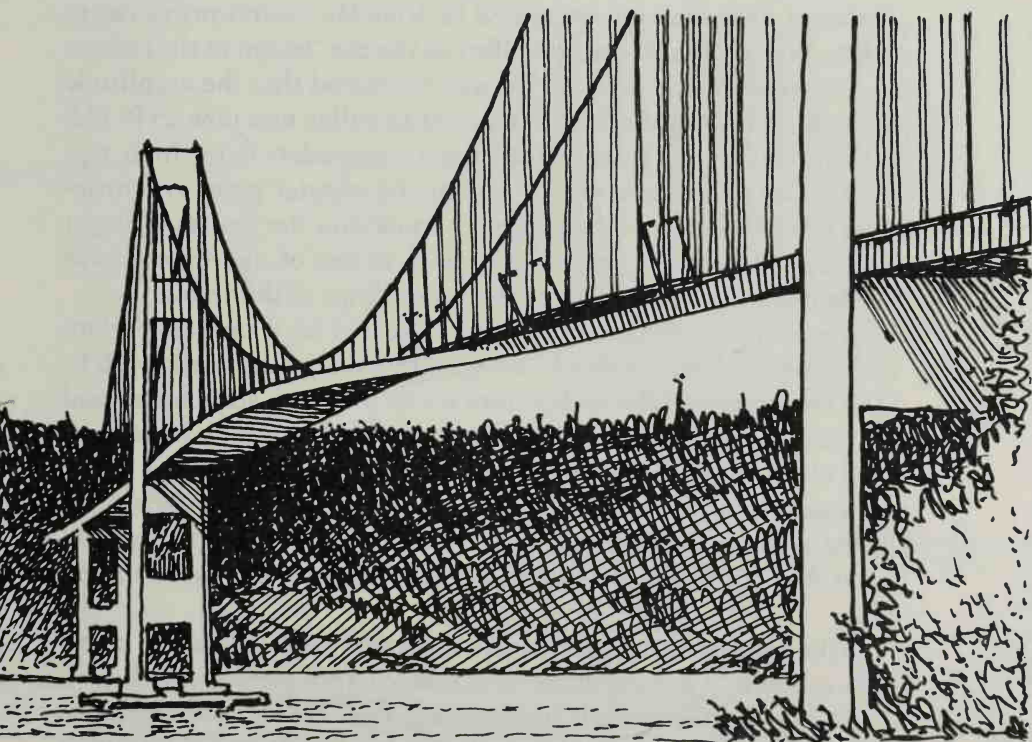
7.3 Twisting Motion of Tacoma Narrows Bridge

circular arc. Shortly before 10:00 A.M. Arkin again checked the wind velocity and saw that it had increased to 42 mph (67 km/h) and that the movement of the bridge deck had heightened dramatically; by his count, the deck rose and fell at the center of the bridge 38 times per minute with a 3 ft. (0.9 m) amplitude. Greatly concerned, Arkin halted all traffic, and Professor Farquharson, who happened to be at the site that day, observed that the up-and-down motion of the center span consisted of at least nine vertical undulations while the bridge was also deflecting laterally by as much as 2 ft. (610 mm). Suddenly the bridge started twisting violently, and the nine-wave motion changed to a two-wave motion while the bridge deck near the Tacoma side appeared to twist to an almost 45° angle (Fig. 7.3).

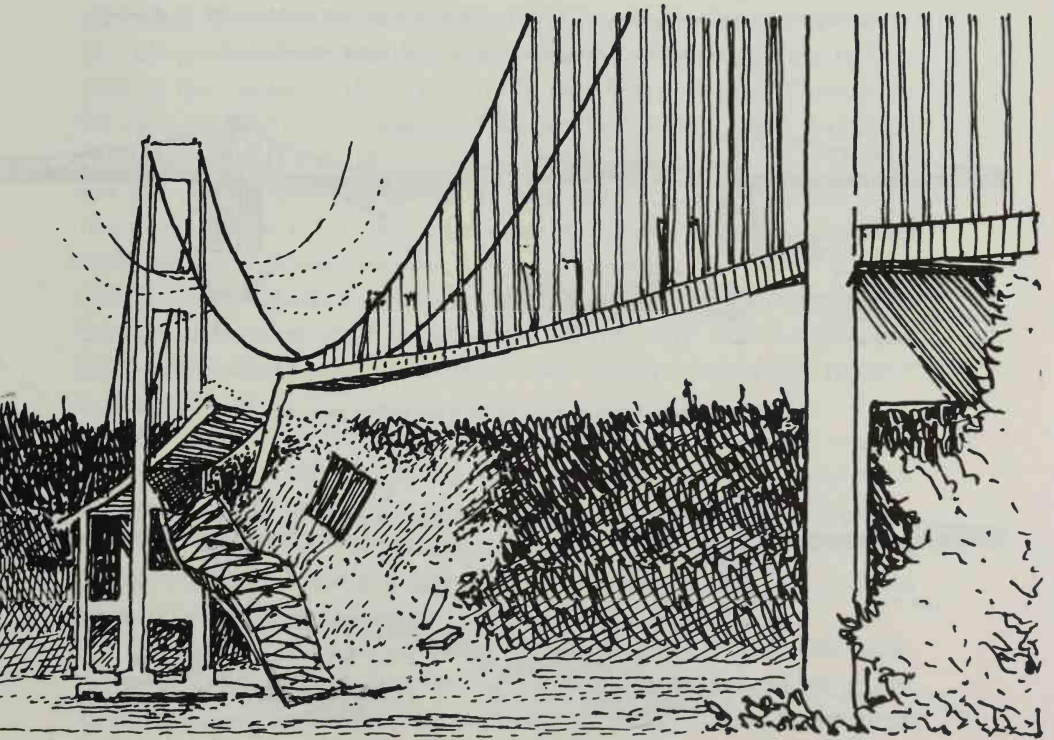
7.4 Tacoma Narrows Bridge at the Moment of Collapse

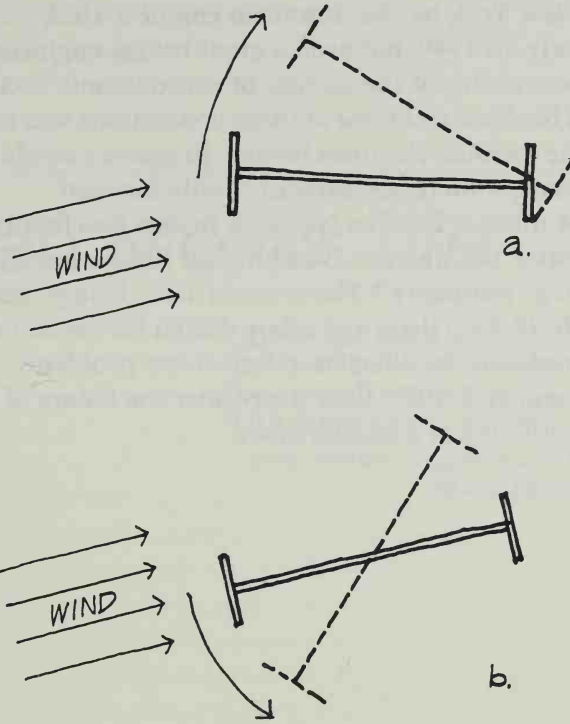
### 7.6 Wind-Induced Twist

\* Recent (1991) studies suggest that the cause may be attributable to vortex shedding, a phenomenon first described by Theodor von Karman. Spiraling vortices can be seen in the wake of a ship moving through water, and similar, though invisible, vortices trail an airplane wing in flight. Two kinds of vortices were shed by the twisting Tacoma Narrows deck. The first is called a Karman vortex street because the periodic shedding creates a continuous pattern of alternating vortices. However, these vortices were out of sync with the natural frequency of the bridge and therefore could not contribute to a buildup of motion. The second was a flutterlike complex pattern of vortices with a frequency coincident with the bridge's natural frequency that rapidly reinforced the destructive torsional oscillations. It is difficult to state whether the twisting oscillations of the deck caused these vortices or whether the vortices caused the deck oscillations, but at the present time this new assumption must be considered the best interpretation of the cause of the collapse.

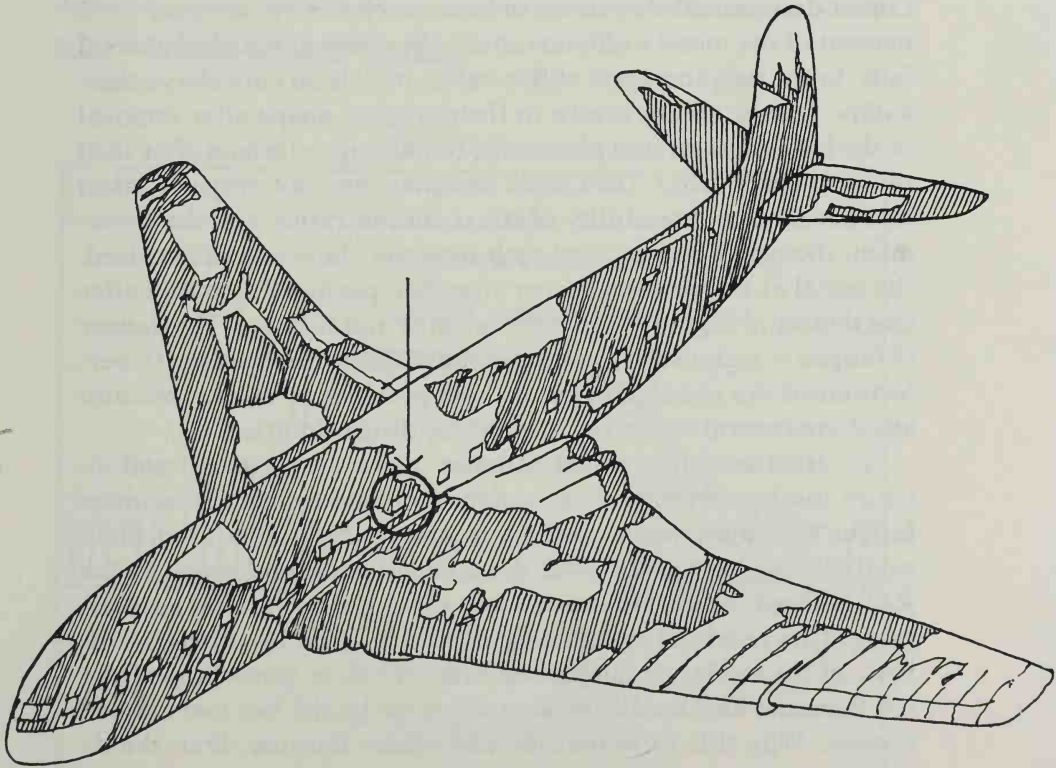
8.1 Comet Airliner with Recovered Sections Shown Shaded

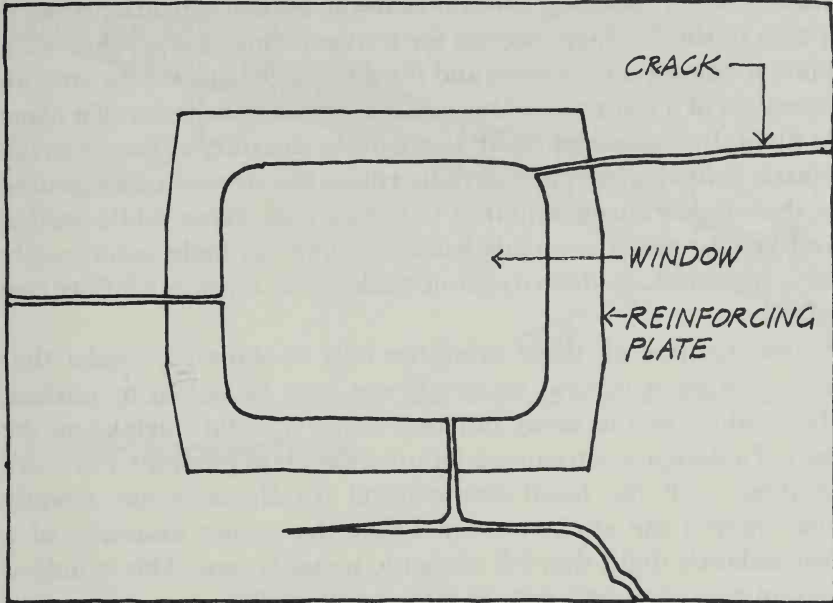
8.2a Cracks around Window

De Havilland had tested samples of the corner panel and an entire fuselage section of each plane, concluding that in terms of fatigue the cabins were good for a service life of about ten thousand flights or ten years. After the accident a test performed by the RAE showed failure after only three thousand cyclic load applications. This result, although only one-third of de Havilland's estimate of the fuselage's fatigue life, was still three times larger than the thousand-load applications experienced by the last two crashed Comets. Why this incompatible difference? Because, first, the de Havilland test did not accurately represent the actual cabin since complete windows were not fitted into the test section. Then there

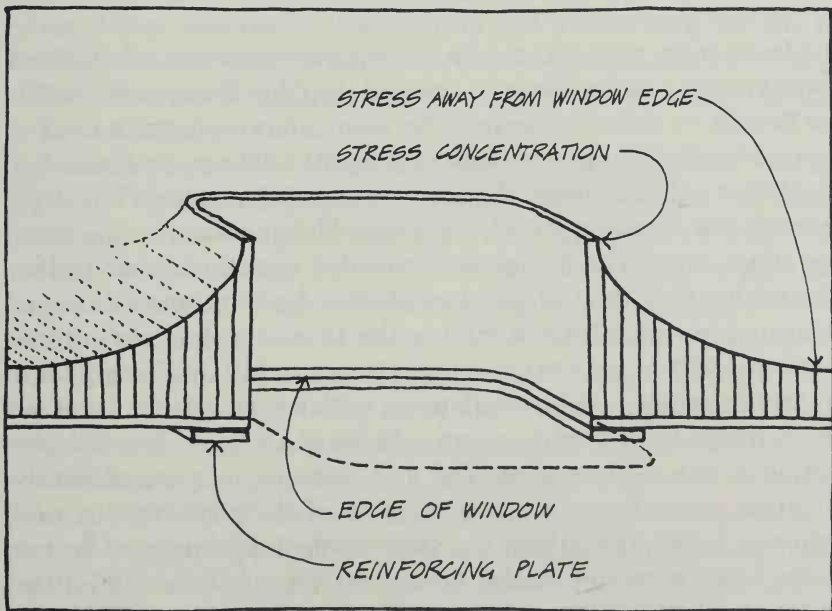
8.2b Stress Concentration at Window's Edge

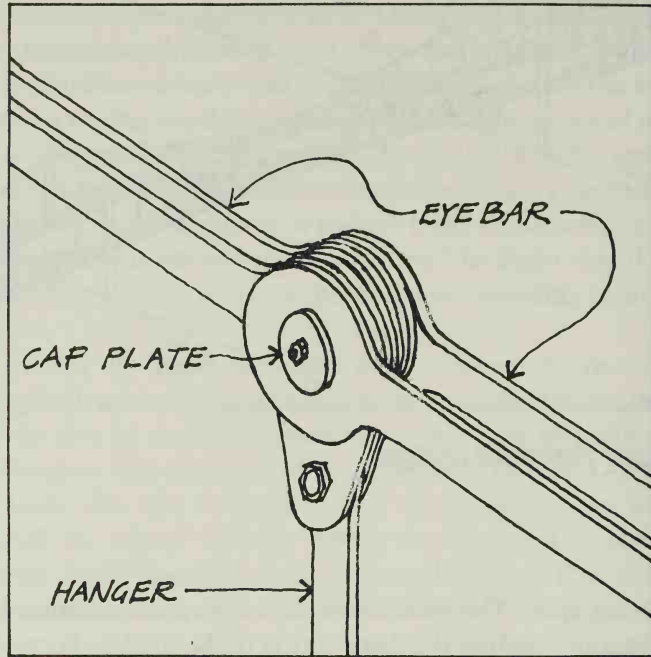
8.4 Typical Eybar Joint

Modern suspension bridges use steel cables introduced by French engineers around 1830, but the Point Pleasant Bridge, like other U.S. suspension bridges of the time, was supported by two steel chains, each consisting of 50 ft. (15 m) long *links* with *two* parallel forged steel eyebars each. (A cable today generally consists of thousands of individual wires.) An *eyebars*, as the name implies, is an iron or steel bar with enlarged ends pierced by holes; a pin through the holes of adjoining links, 12 in. (300 mm) in diameter in the Silver Bridge, connects them to make a chain and is held in place with bolted cap plates (Fig. 8.4). The Silver Bridge had a central span of 700 ft. (213 m), with two 380 ft. (116 m) side spans, and approach spans supported by piers at either end of the bridge leading to the anchorages for the eyebars chains. As originally built in 1928, the two-lane bridge had a timber deck and two sidewalks. For added durability, the roadway was replaced in 1941 with a

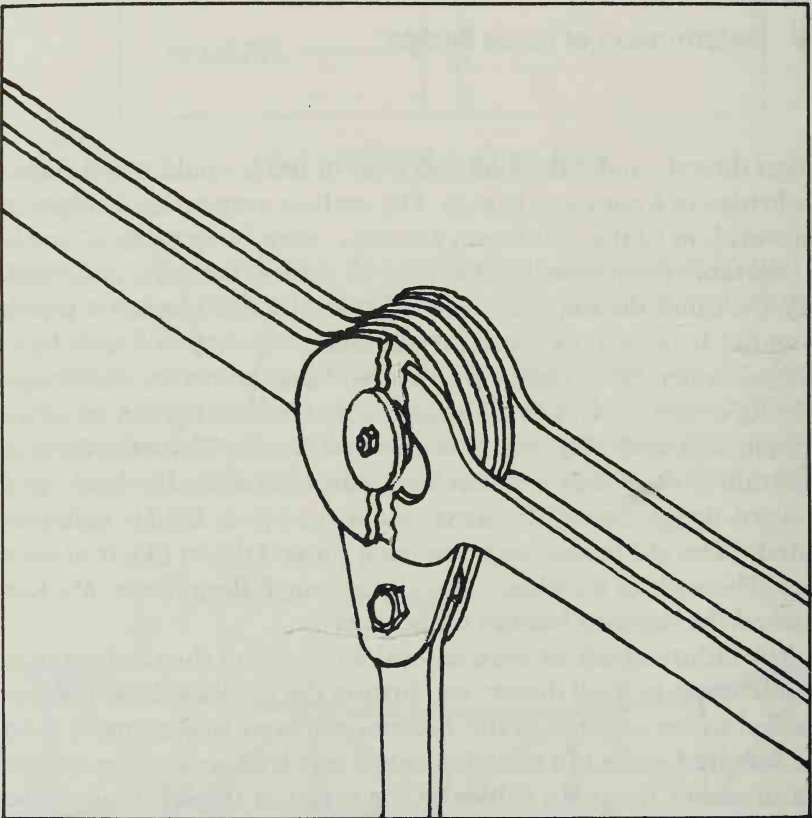
8.7 Cracked Eyebar

The need to discover the cause of the Point Pleasant failure led to the decision to salvage and store as many elements of the fallen spans as possible. Fractured, bent, and rusting segments were reassembled into a giant jigsaw puzzle on a 27 acre (10.9 ha) field near the banks of the Ohio. The inquiry panel and its consultants, some of the best bridge engineers and scientists in the country, had the task of locating the bar that broke first. Laboratories were engaged in the conduct of microscopic examinations of the steel in

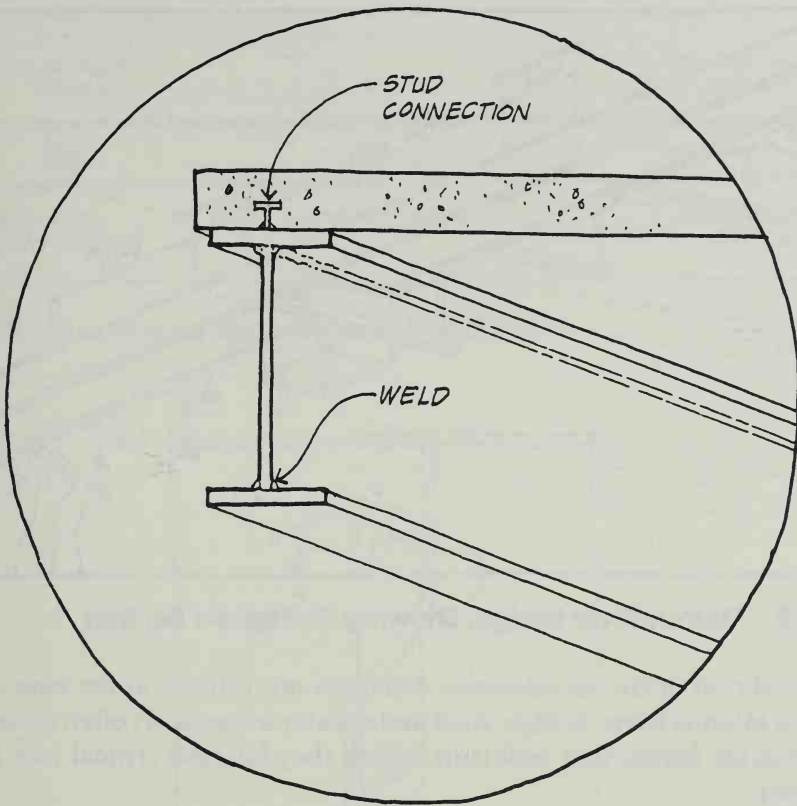
## 9.1 Typical Welded Bridge Girder

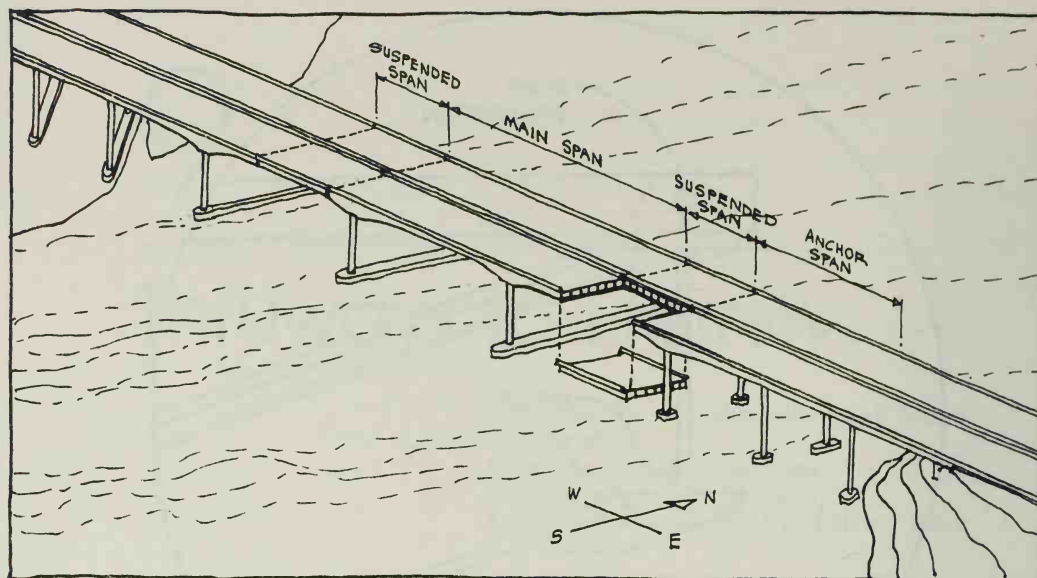
## 9.2 Mianus River Bridge, Showing Collapsed Section
