**WHY  
BUILDINGS  
FALL DOWN**

How Structures Fail

MATHYS LEVY  
and  
MARIO SALVADORI

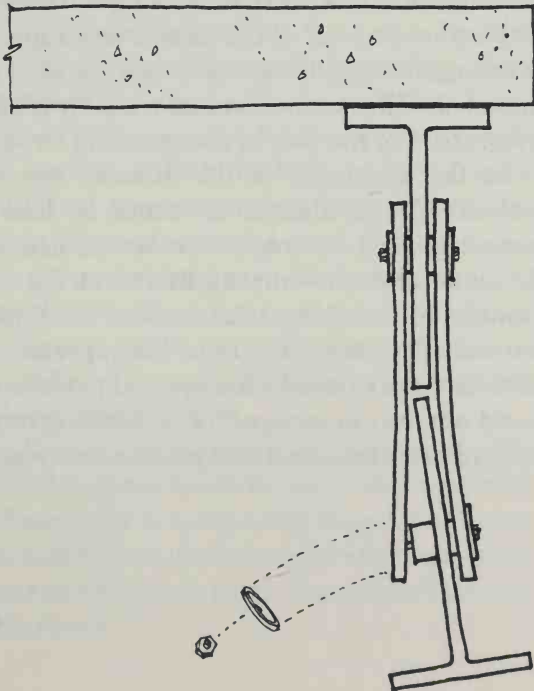
9.6 Failure of Hanger

We can now reconstruct the events leading to the collapse of the Mianus Bridge. Over the bridge's twenty-five years, corrosion builds up between the hanger plates and the pins because of the constant wetting action of rain, brought on by the paving over of the floor drains. Each time a car or truck passes over the bridge, the skew effect imposes a lateral force on the hanger plates, contributing to the tendency of the hanger plates to be pushed off the pin. At the southeast corner of the suspended span, the force of corrosion, aggravated by the skew effect, is so large that it causes the restraining pin cap to dish out and possibly pop off. Sometime before the collapse, hours or days earlier, the bottom of the inside hanger plate slips off the pin (Fig. 9.6), causing a transfer of the

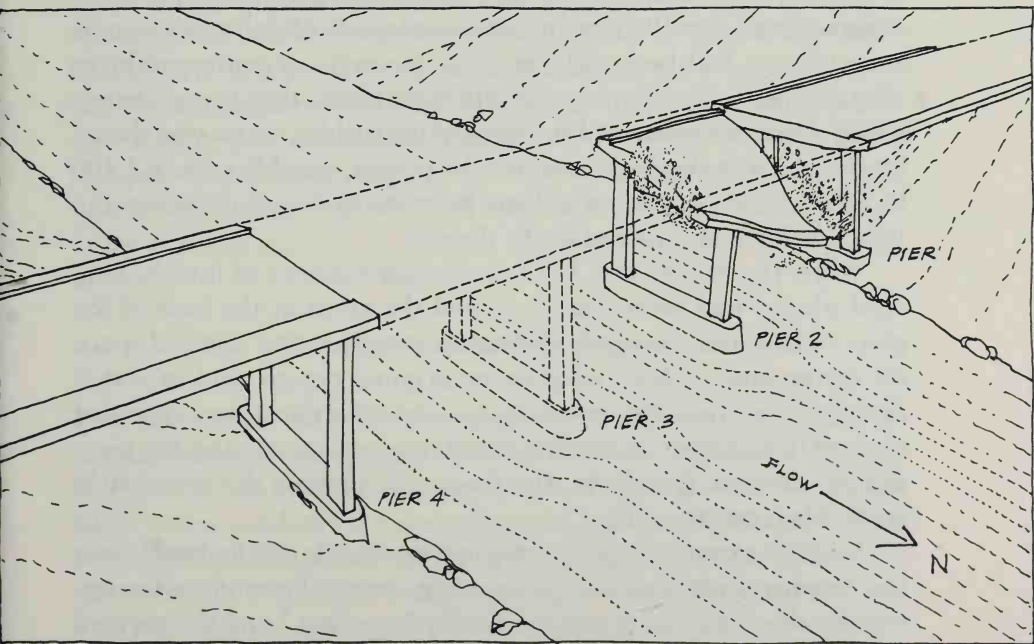
9.9 Collapsed Schoharie Bridge

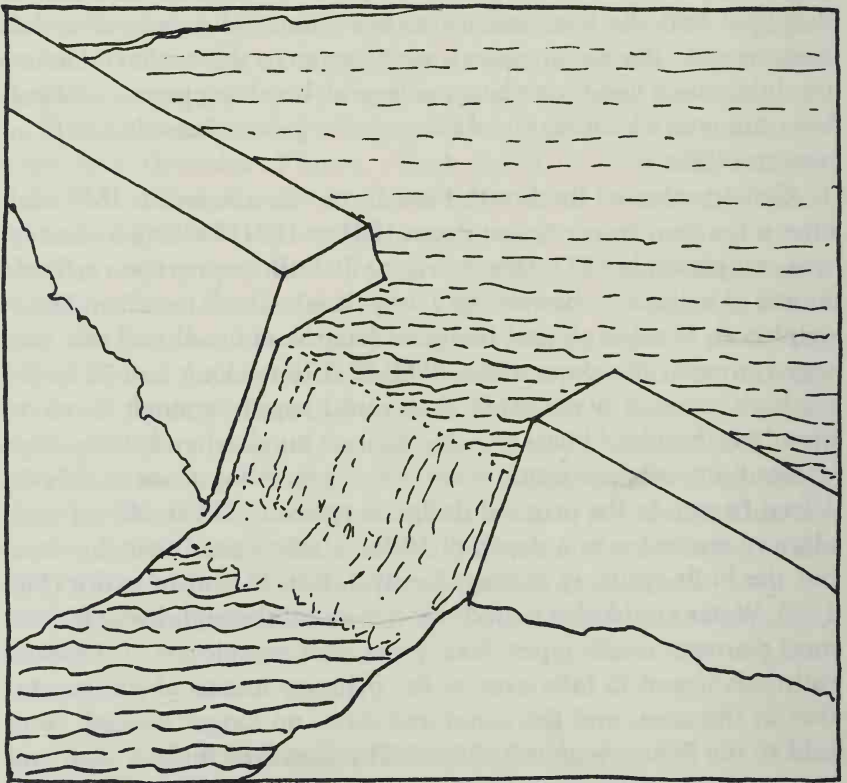
**11.1 South Fork Dam: Original Construction**

and philanthropy as Andrew Carnegie and Henry Clay Frick. The dam repairs requested by the new owners modified it dangerously: The outlet pipes, no longer needed to feed the canal, were removed, the dam was lowered by 2 ft. (0.6 m) in order to accommodate a wider roadway on its top, a trestle bridge was constructed across the spillway to allow the road to go from one end of the dam to the other, and a screen was placed in front of the trestle to prevent the loss of fish when water overtopped the spillway (Fig. 11.2). The reduced width of the as-built spillway, together with all these modifications, reduced the capacity of the spillway to almost one-third of that intended in the original design. The scene was set for a disaster.

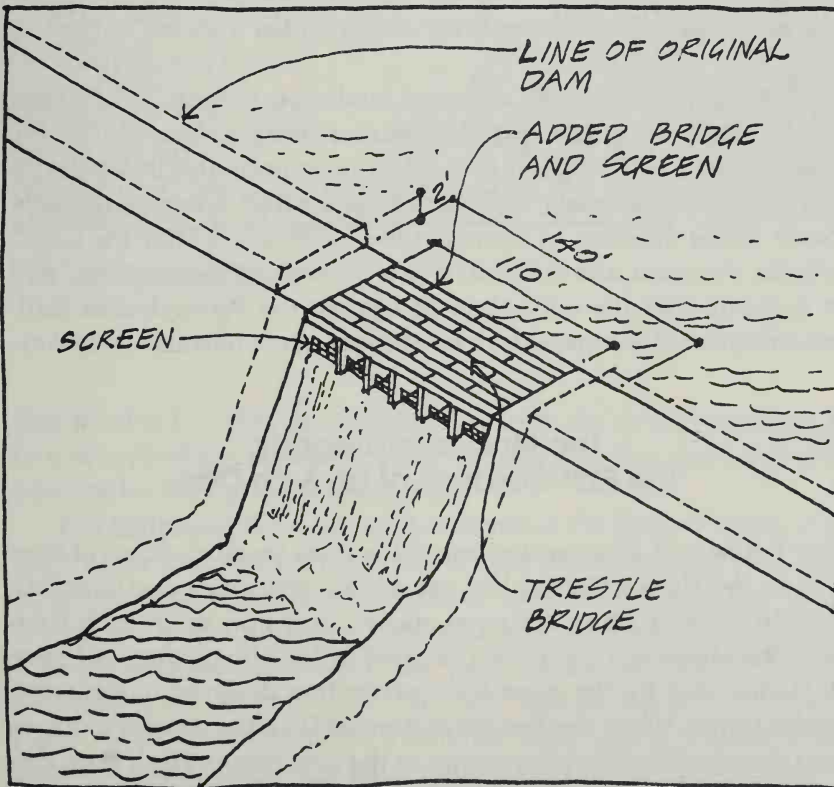
11.2 South Fork: Modified Dam and Spillway

On May 30, 1889, it started to rain at 9:00 p.m. When the resident engineer engaged by the South Fork Club, John G. Parke, Jr., awoke the next morning, he noted that the water in the lake behind the dam had risen about 2 ft. (0.6 m). Concerned by the continually rising water level, he kept observing it while eating breakfast, then rode by horse to the South Fork village and sent a telegram to warn officials in Johnstown of the dangerous situation. By noon, when he returned to the dam, water was already flowing over it, and "as I crossed the breast (the roadway along the crest of the dam) at this time [I] found the water was cutting the outer face of the dam." The water was already 7.5 ft. (2.25 m) above the normal lake level, almost at the top of the cut-down dam.

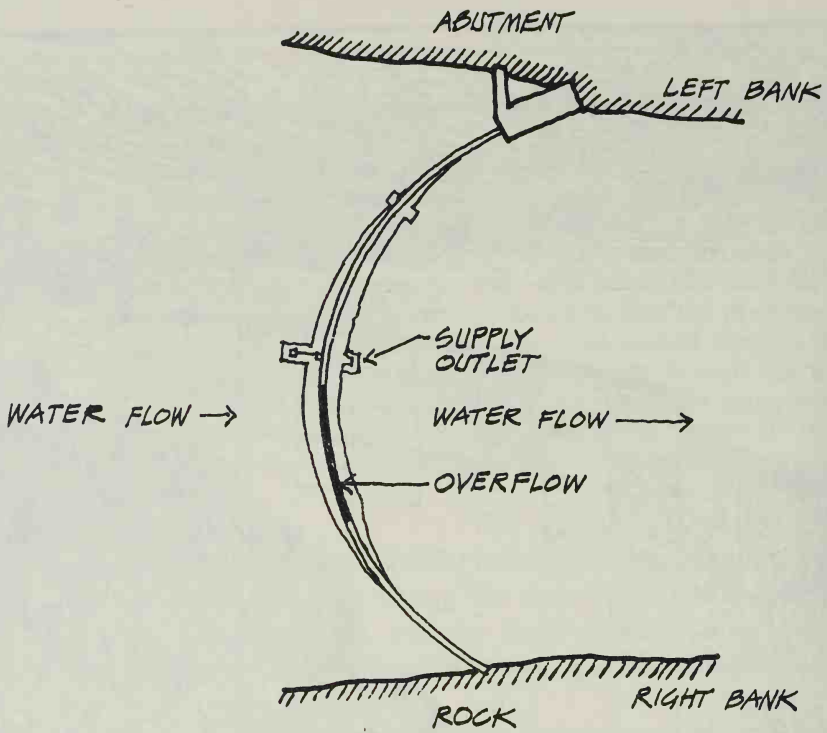
11.4 Plan of Malpasset Dam

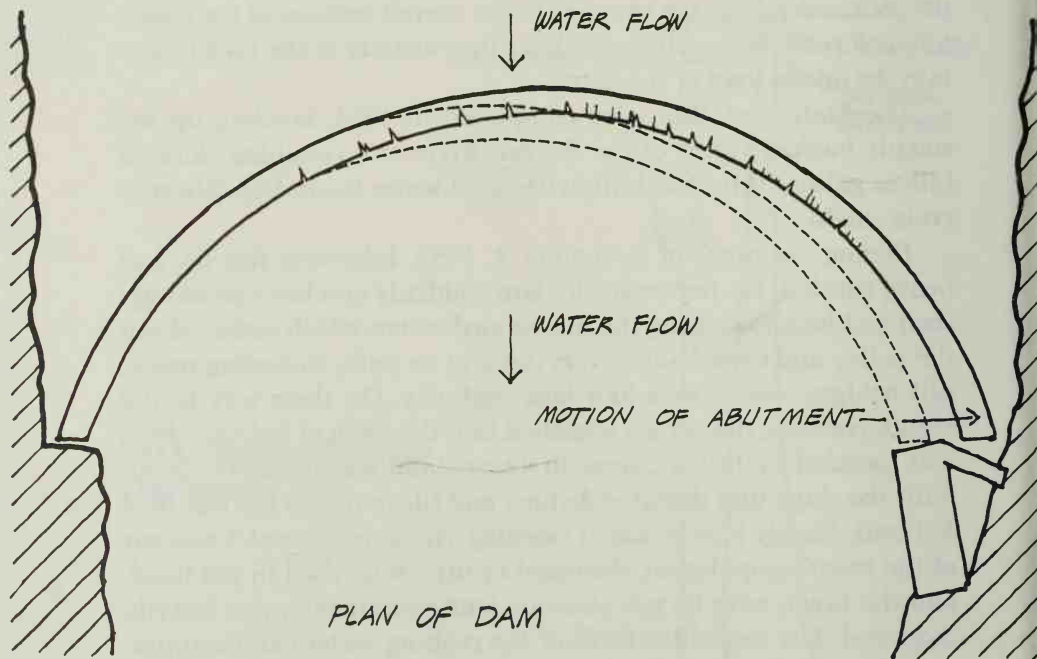
11.6 Failure of Arch Owing to Displacement of Abutment

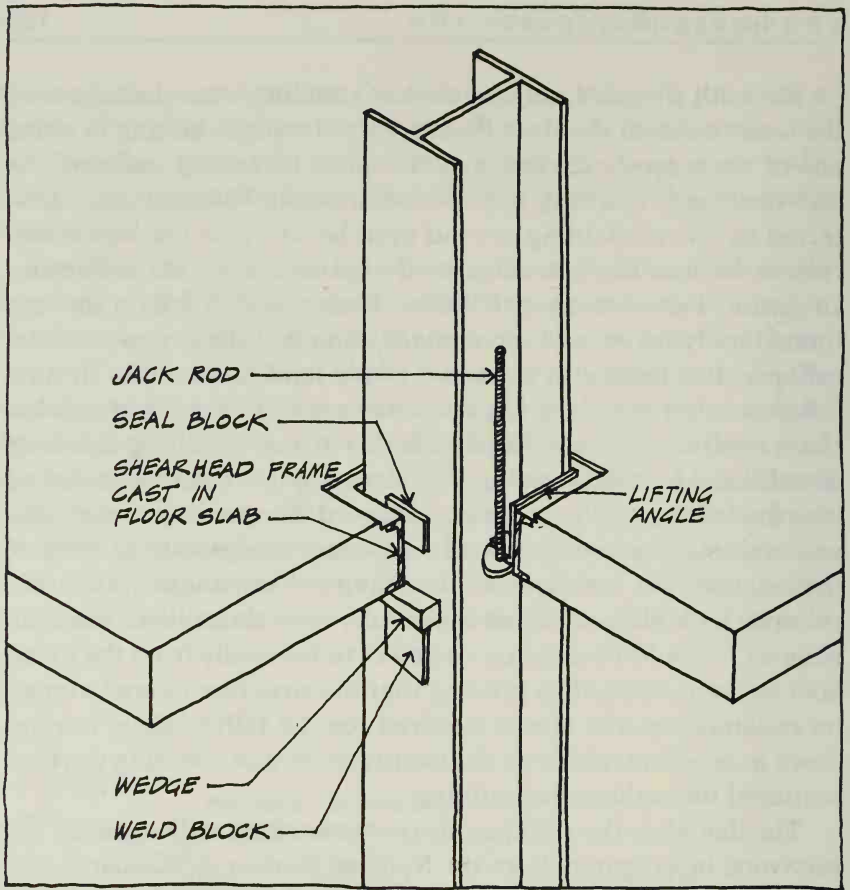
12.4 Typical Shearhead Arrangement

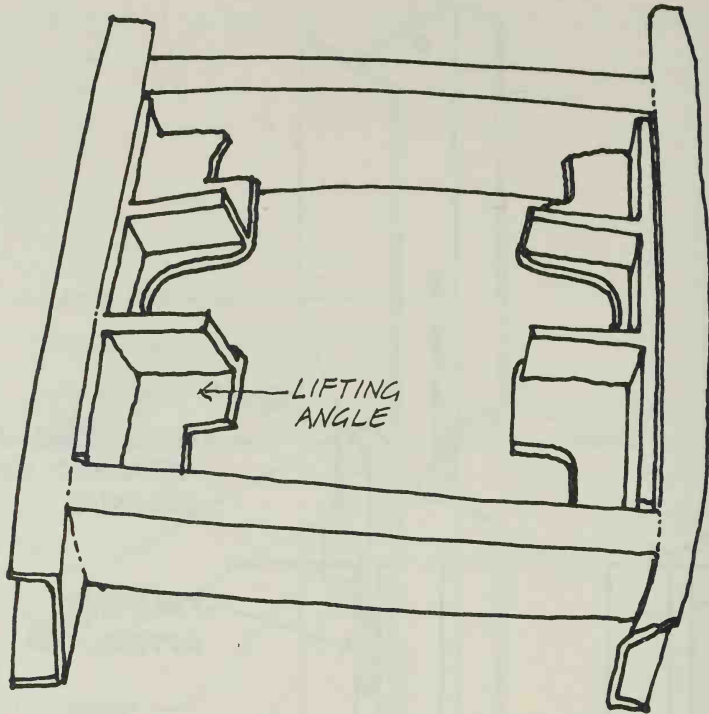
### 12.6 Failed Shearhead Showing Rotation of Lifting Angles

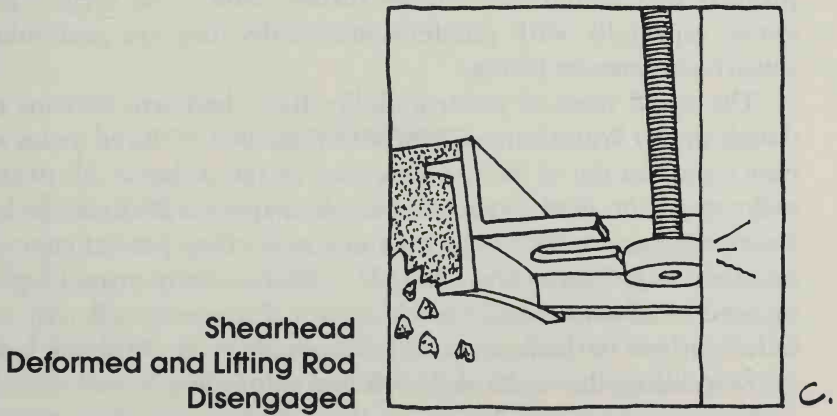
12.7 Failure Sequence

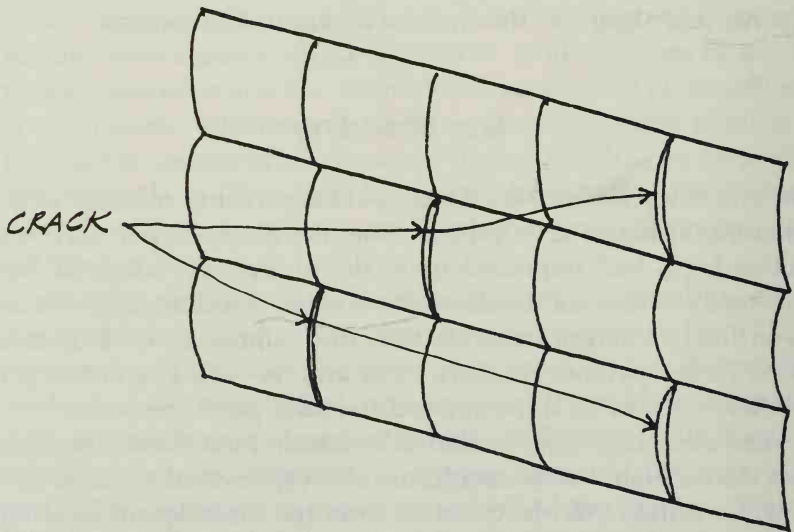
13.6 Bowed-Out Wall Panels

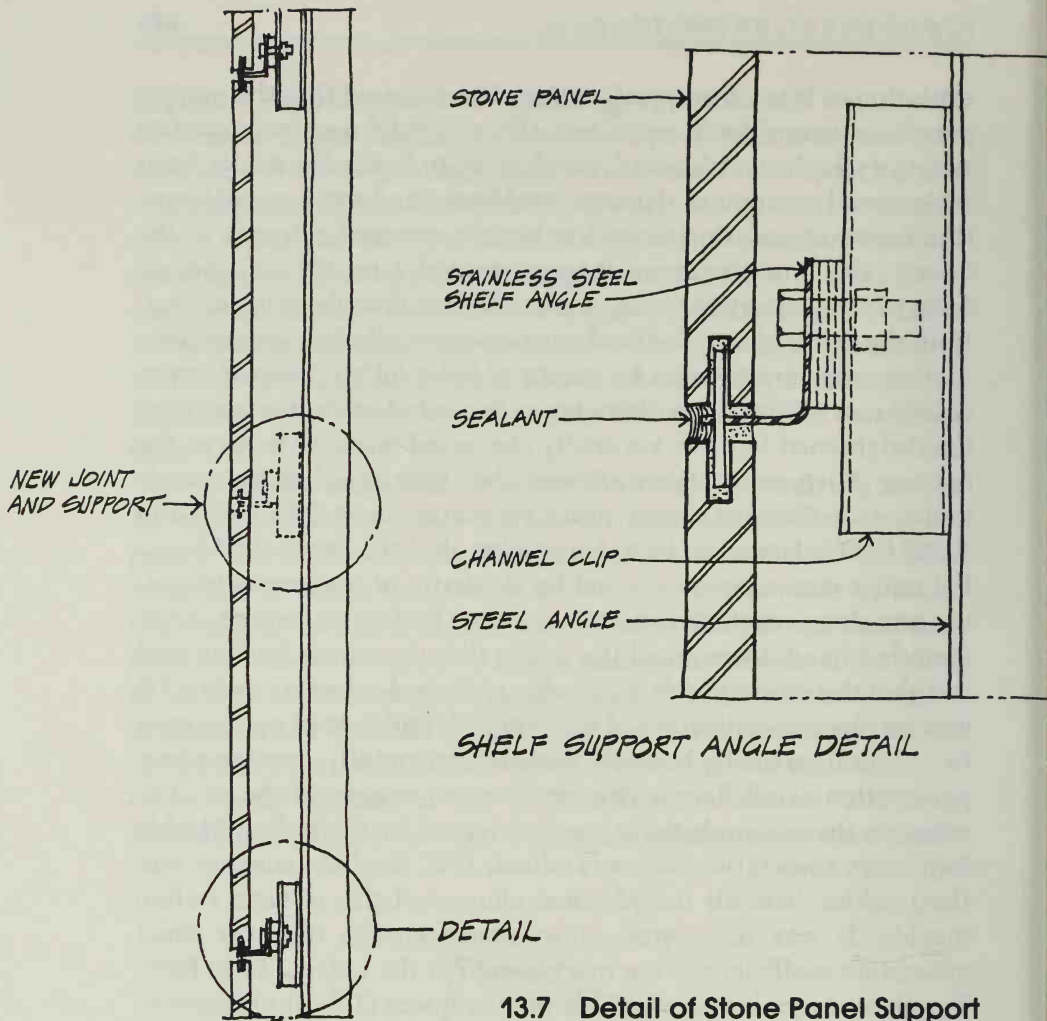
### 13.7 Detail of Stone Panel Support

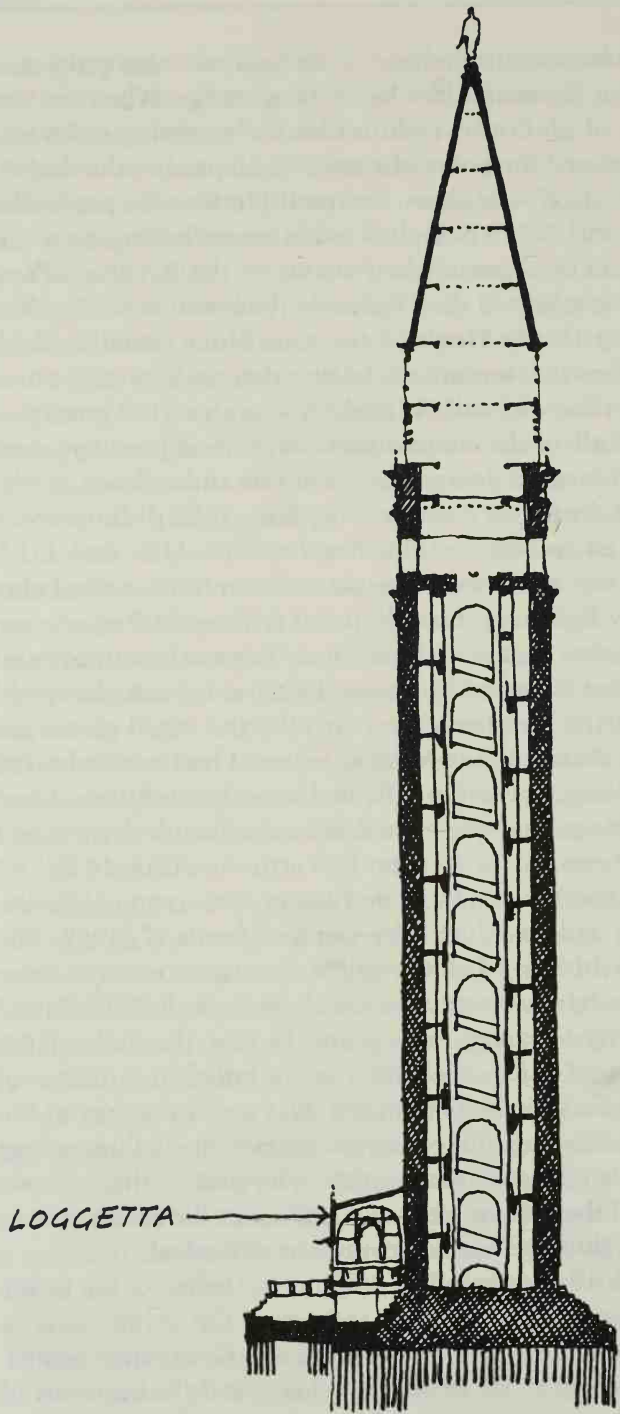
14.2 Section through Campanile of San Marco

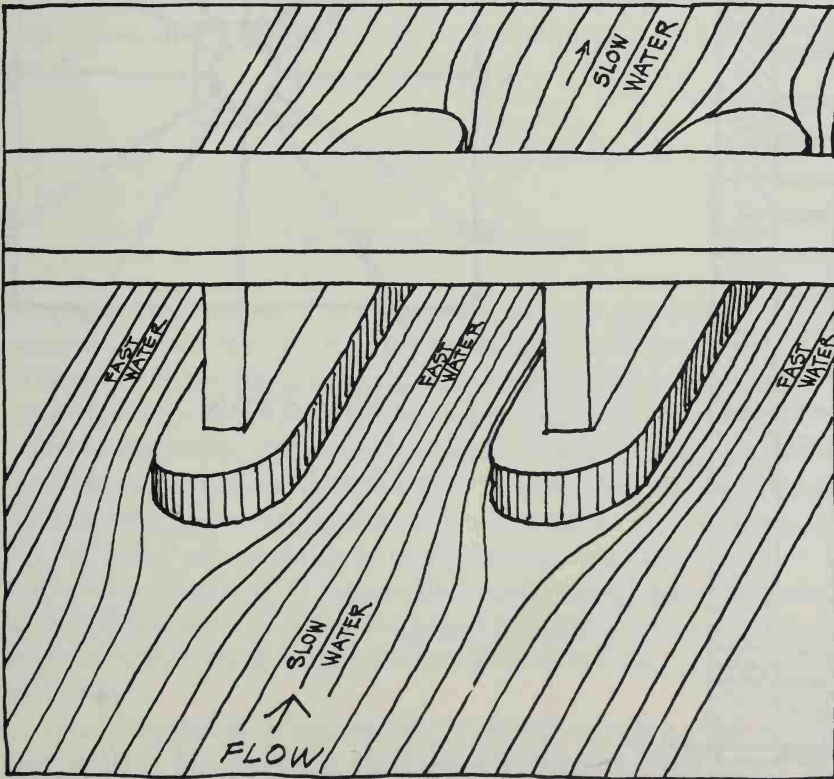
14.5 Flow of Water around Bridge Piers

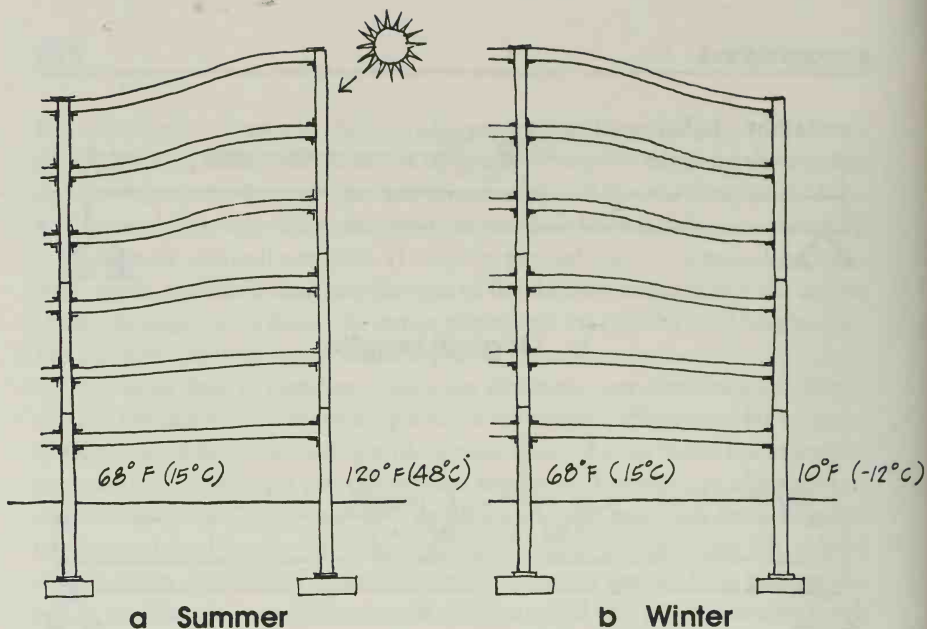
### A3 Thermal Bending of Frame Beams in:

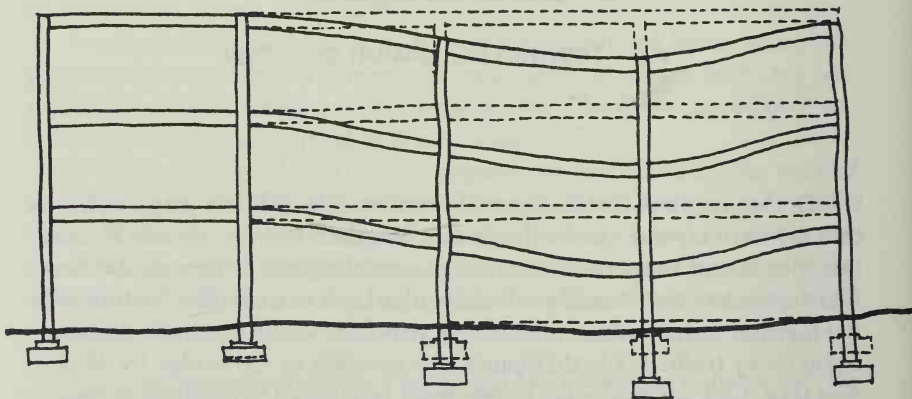
**A4 Uneven Settlement of Building Foundation, Causing Bending of Beams**

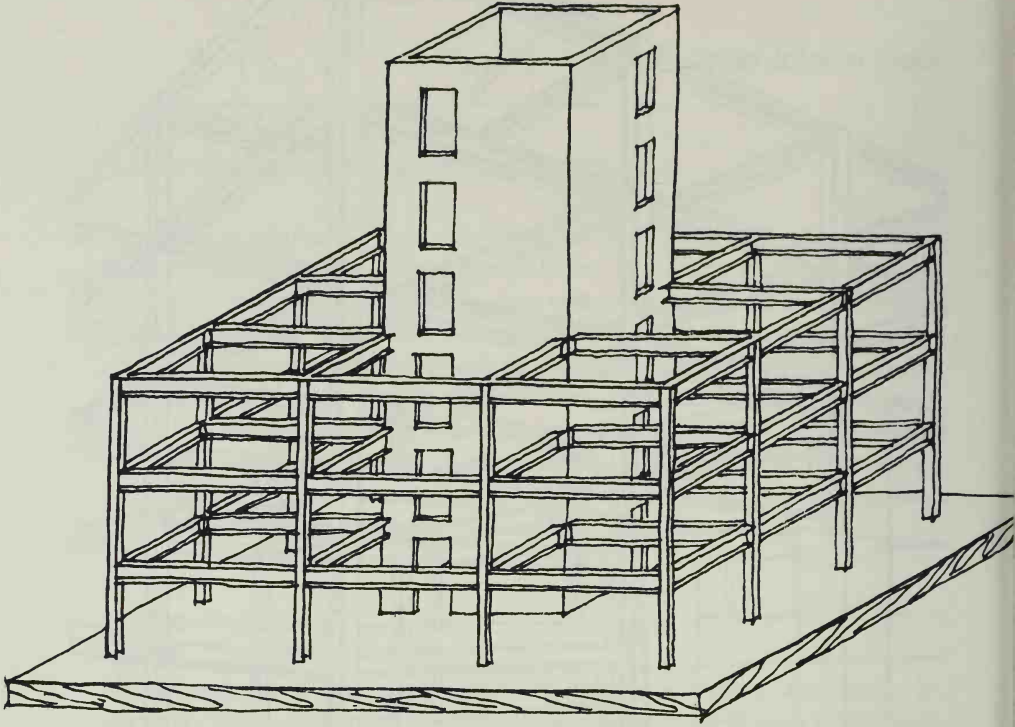
### D24 Steel Frame with Concrete Core

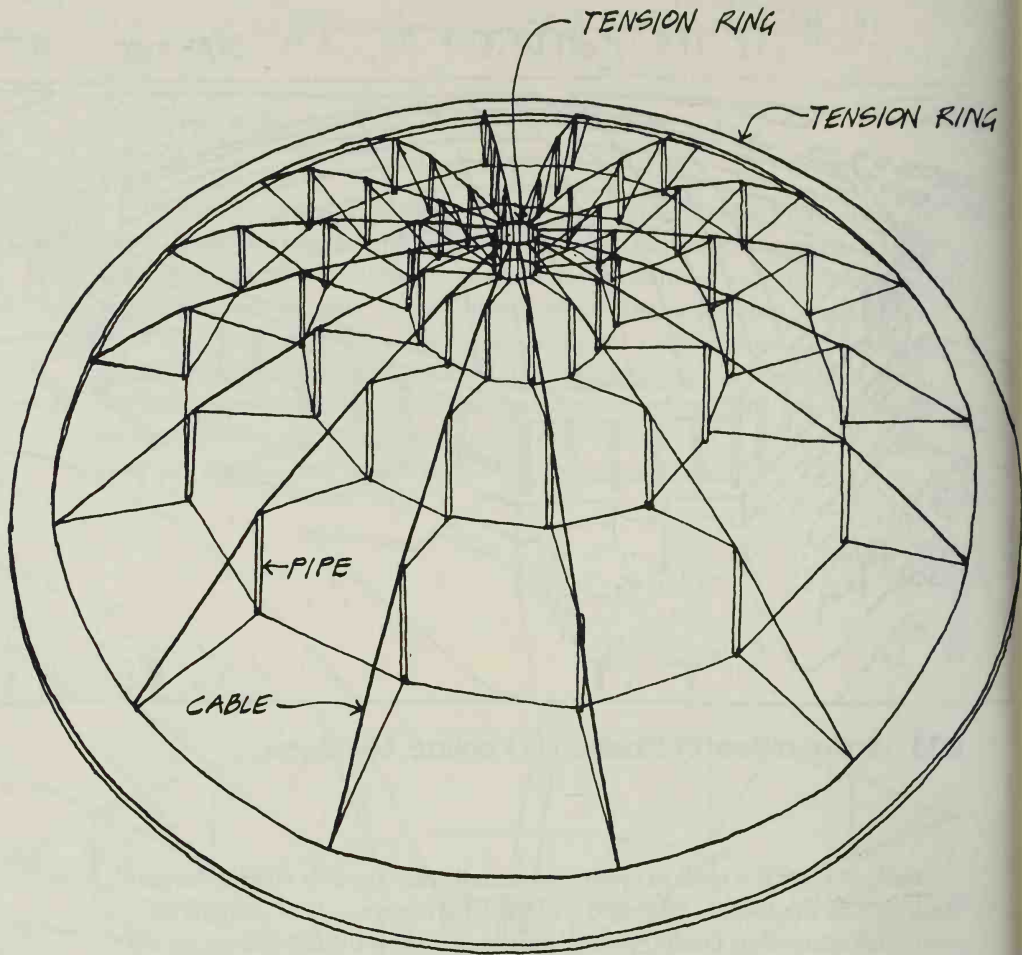
### D34 Tensegrity Roof of Suncoast Dome, St. Petersburg, Florida

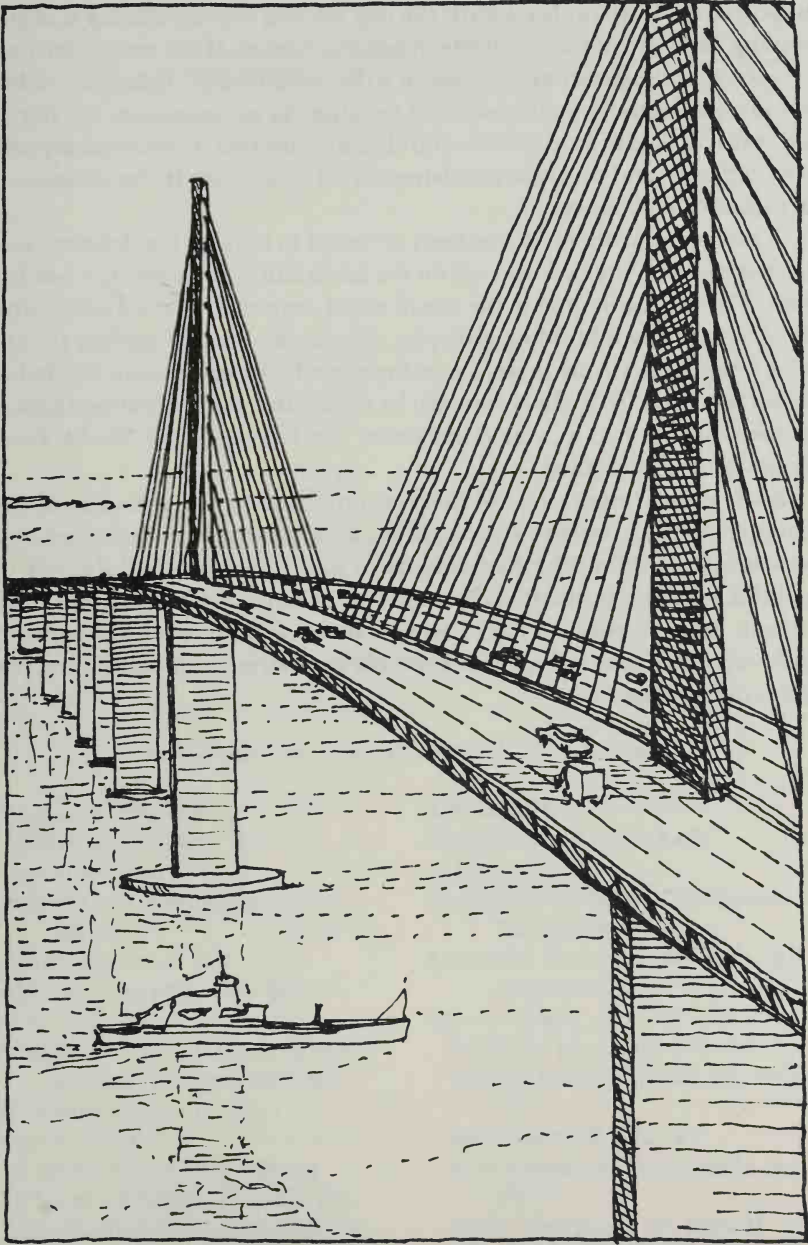
D37 Cable Stayed Bridge, Sunshine Skyway, South of St. Petersburg, Florida
